TINGALPA CREEK - REDLANDS, QLD

STATE OF MARINE DEBRIS REPORT

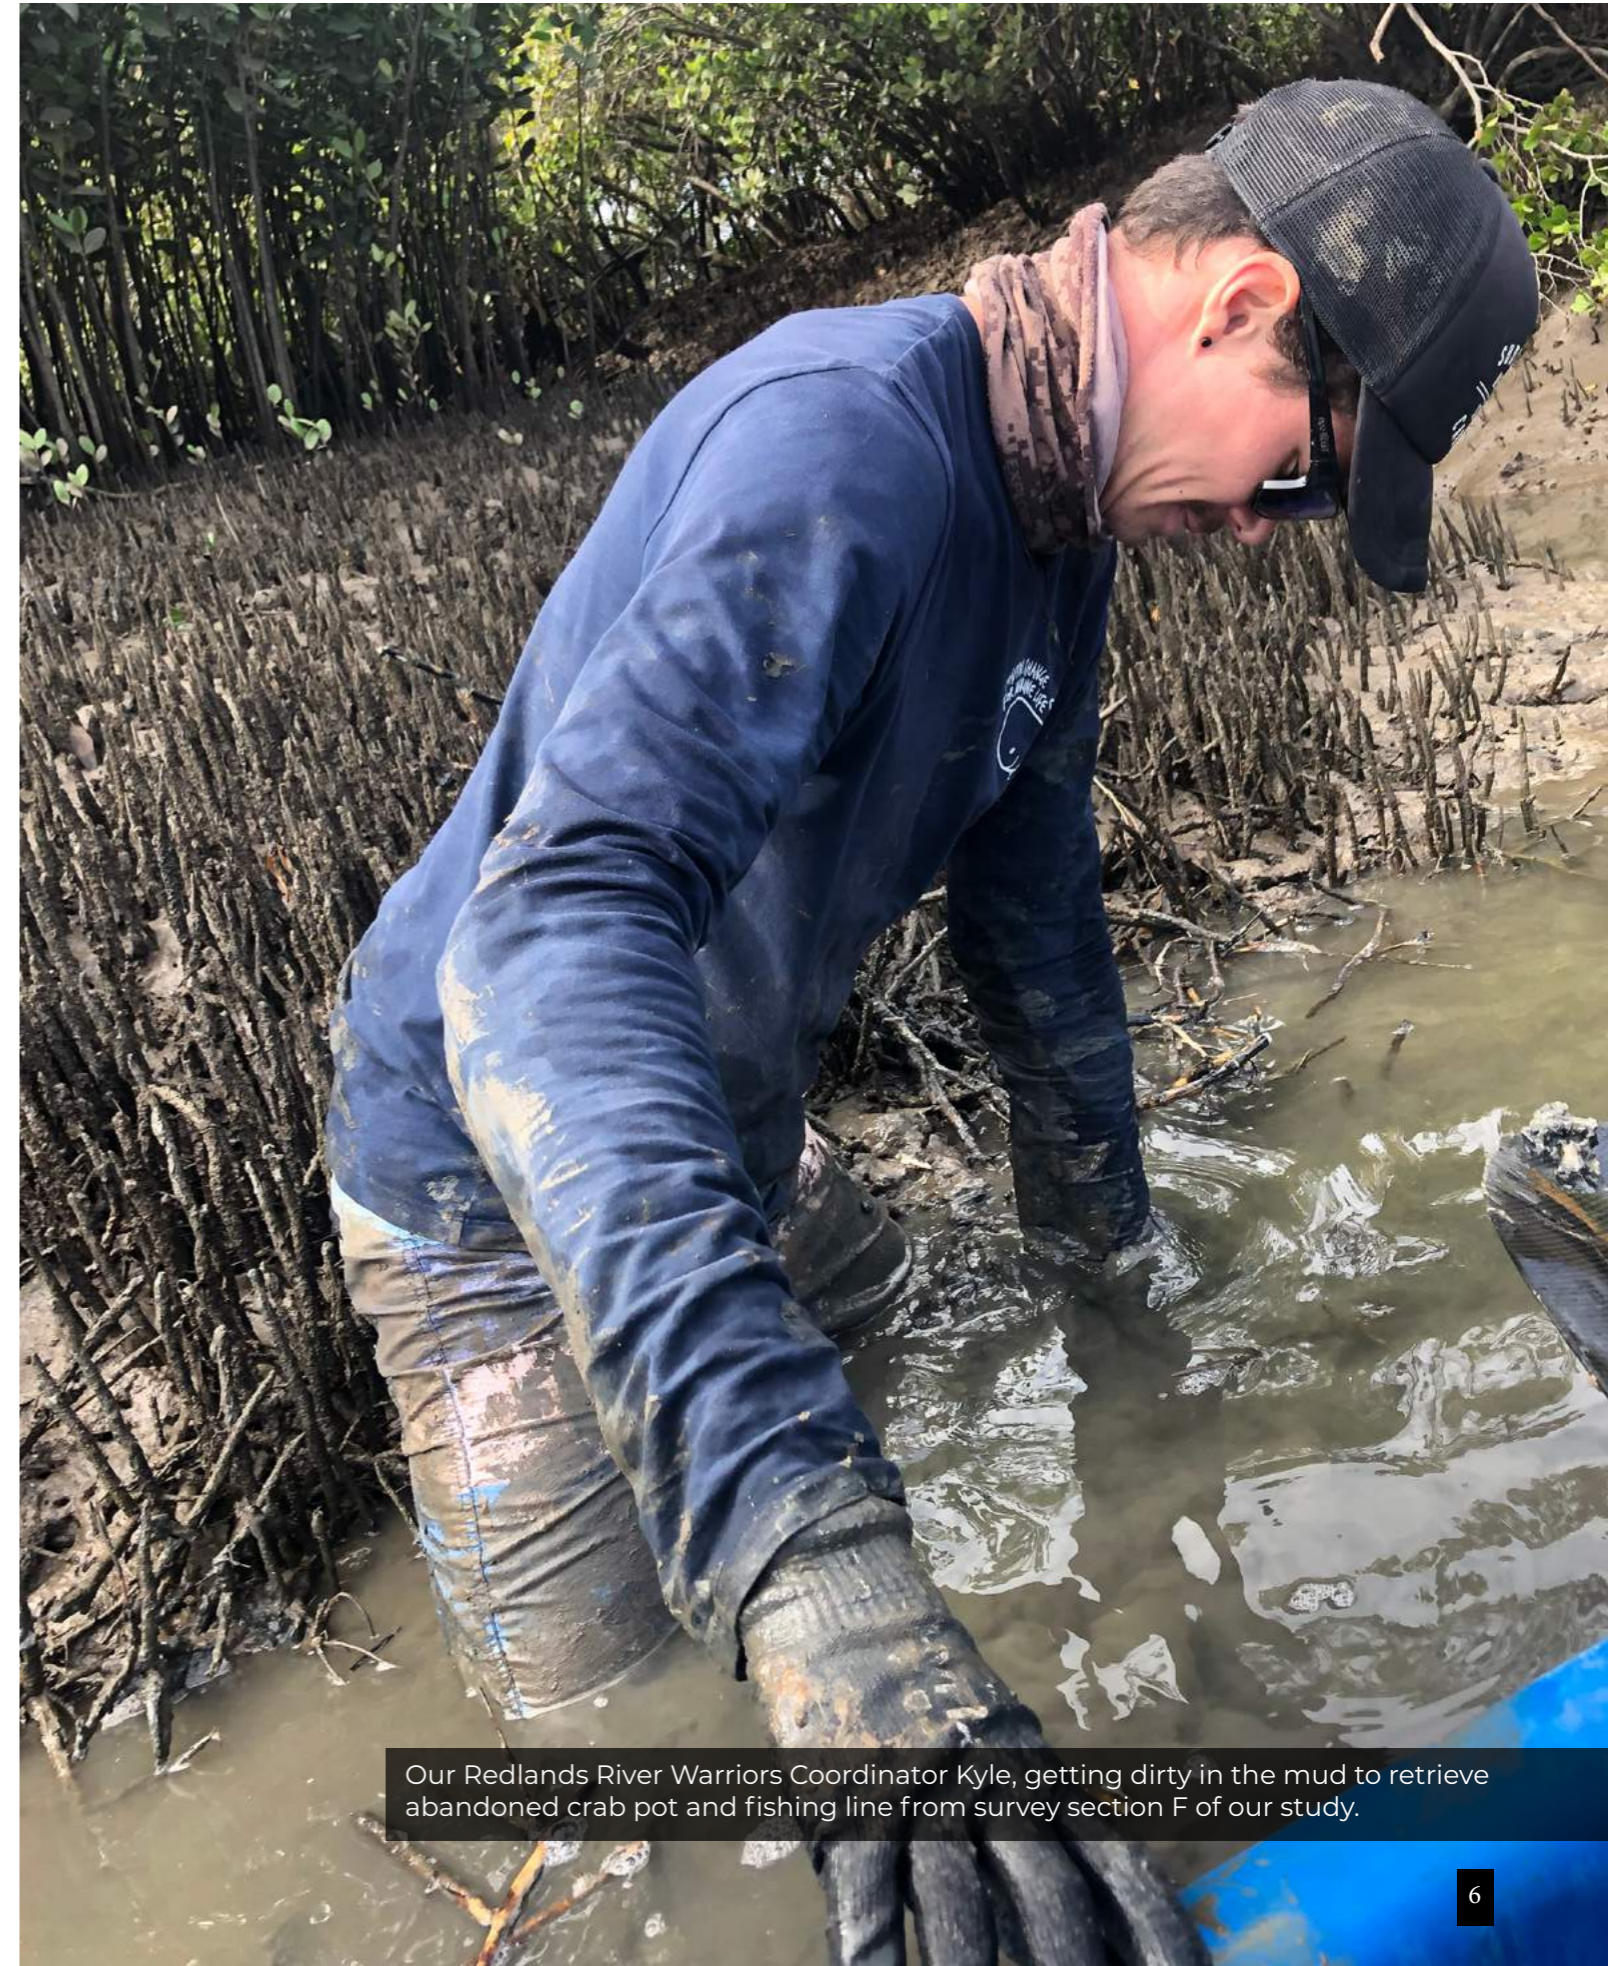
Our Redlands River Warriors Coordinator Kyle, getting dirty in the mud to retrieve abandoned crab pot and fishing line from survey section F of our study.

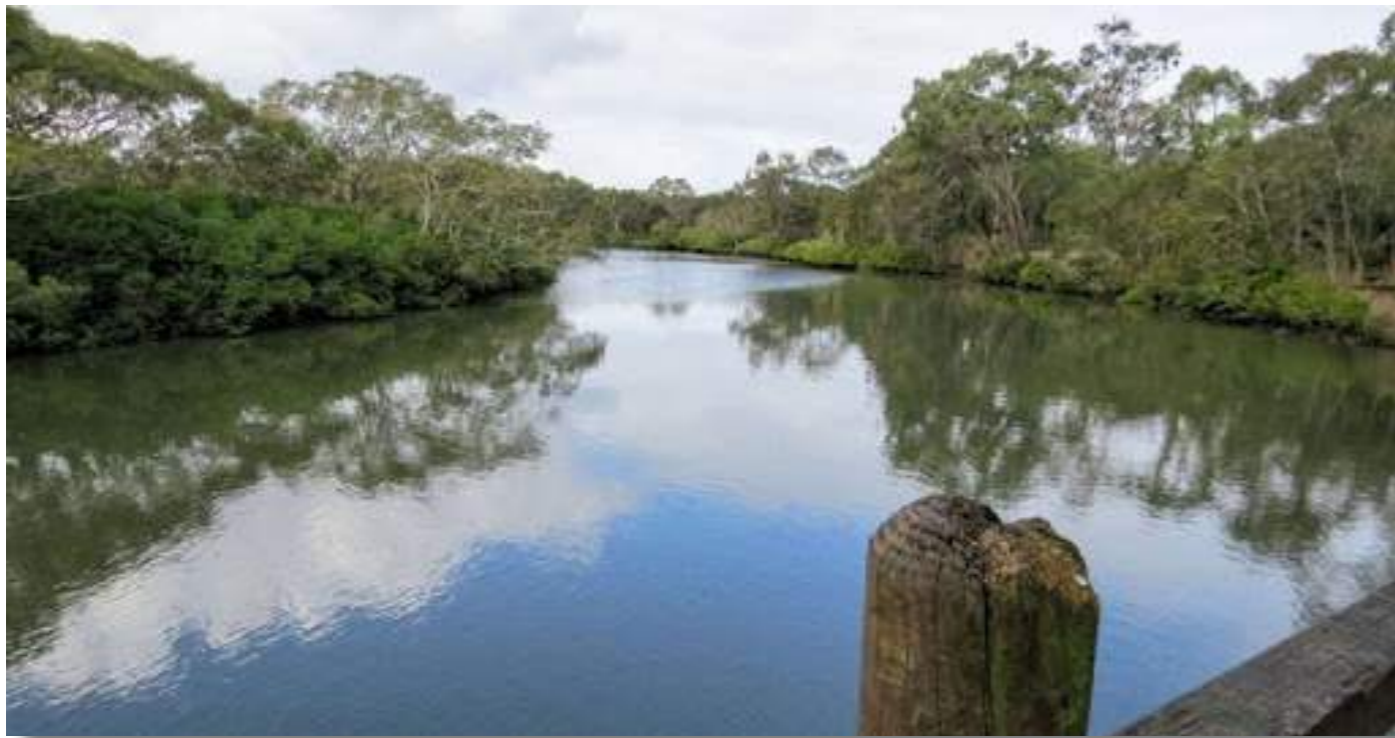
Figure 1. Tingalpa Creek - Redlands, QLD.

Tingalpa Creek (**Figure 1**) is located in south-east Queensland within both the Redlands City Council and Brisbane City Council region. It is a tidal estuary with salt and brackish water with the occasional release of fresh water from the Tingalpa Reservoir after heavy rain. From the base of the reservoir the creek is 13.15km long.

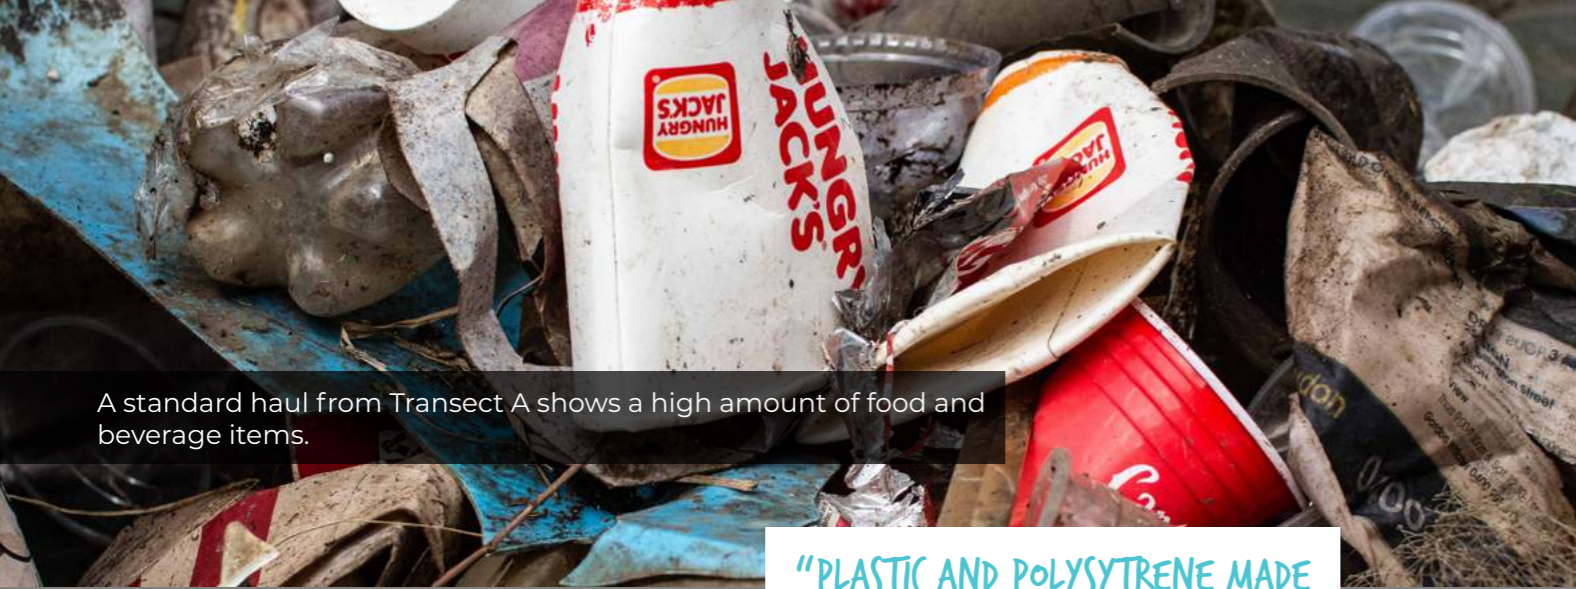
A standard haul from Transect A shows a high amount of food and beverage items.

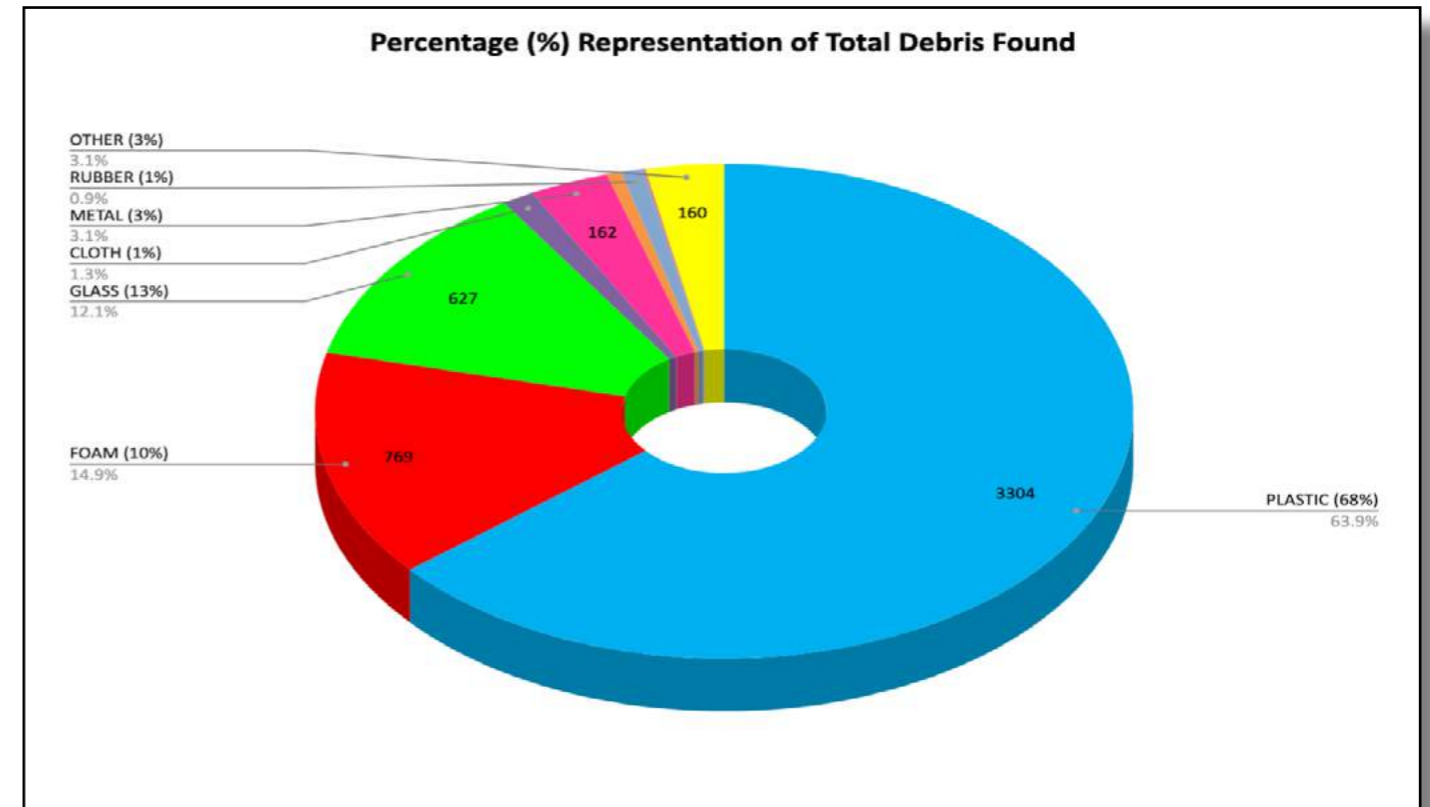
Figure 3. Total debris found - represented as a percentage.

Plastic and polystyrene made up 78.8% of our findings (63.9% Plastic and 14.9% Polystyrene). Glass came in as the 3rd highest category found at 12.1% (Figure 3). From these categories, the most found individual items were fishing line, plastic film remnants, glass bottles and plastic bits and pieces (not film).

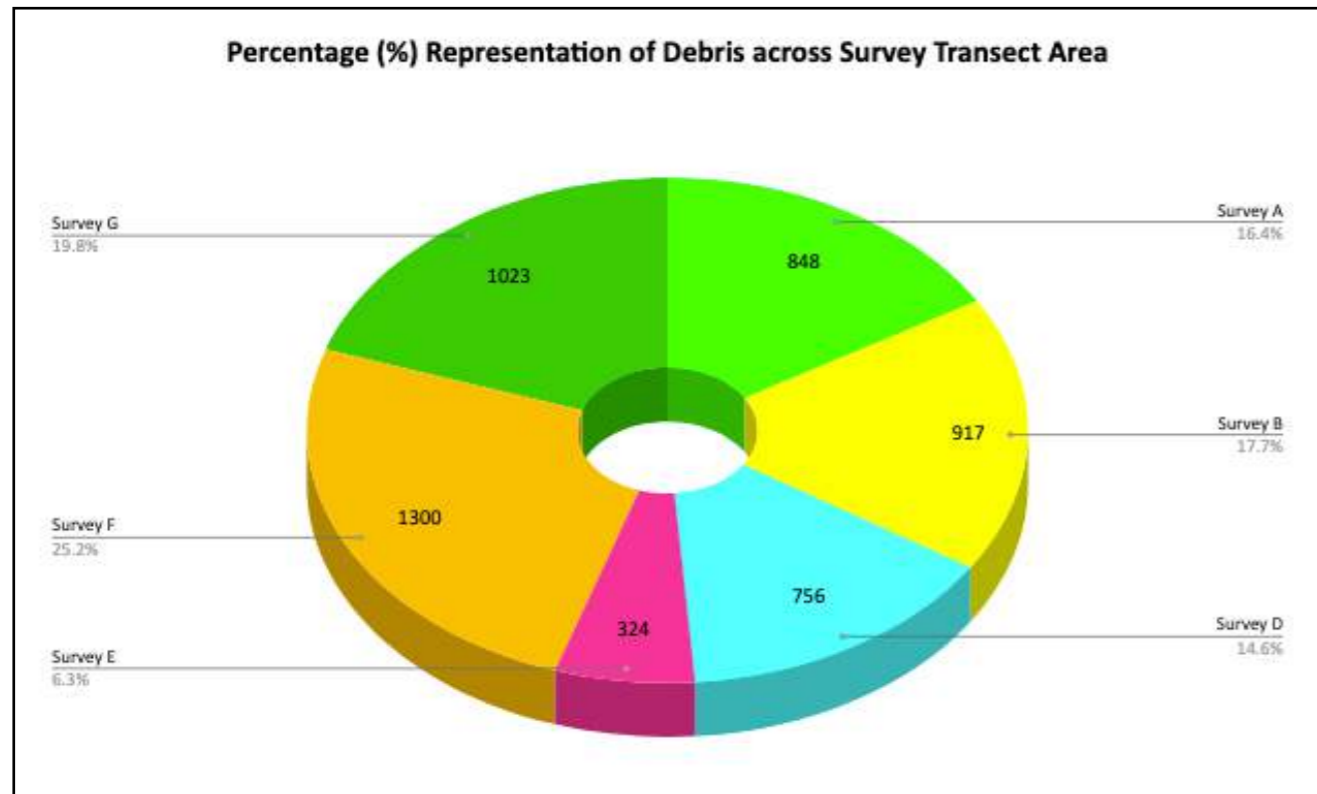
Figure 4. Percentage (%) of debris found by transect area..

Transects F and G were responsible for a cumulative 45% of the total debris found across our 12 surveys, with transect E making up only 6.3% of total debris. These stats

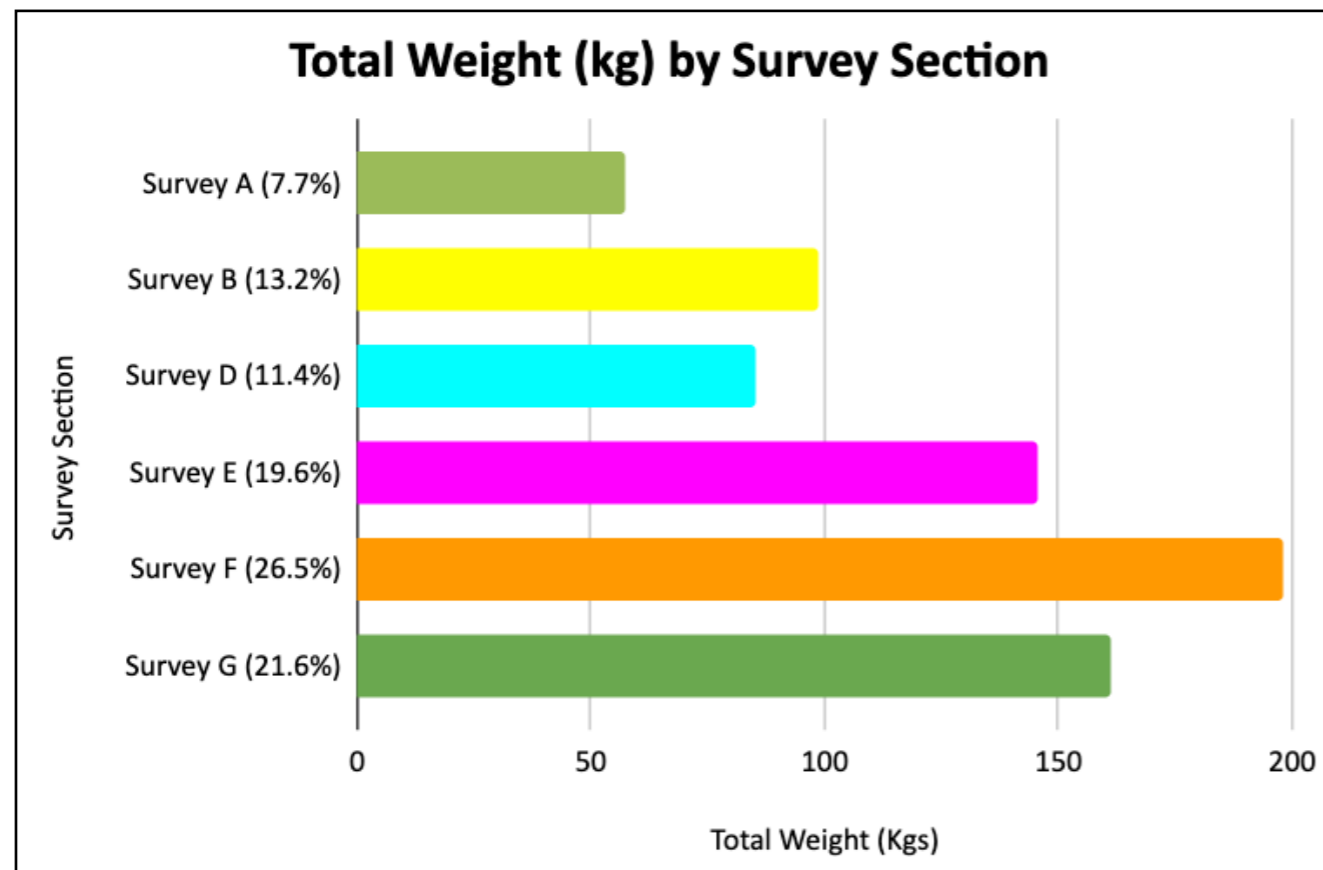
Figure 5. Total weight (kg) by survey section..

will be explored in more depth in the Items of Significance section of this report. In terms of total weight found across our surveys, transects F & G also had the highest weight found, with 48.1% between the two sections (Figure 5). Although this weight represents totals found, it is statistically biased due to the variations of length of each

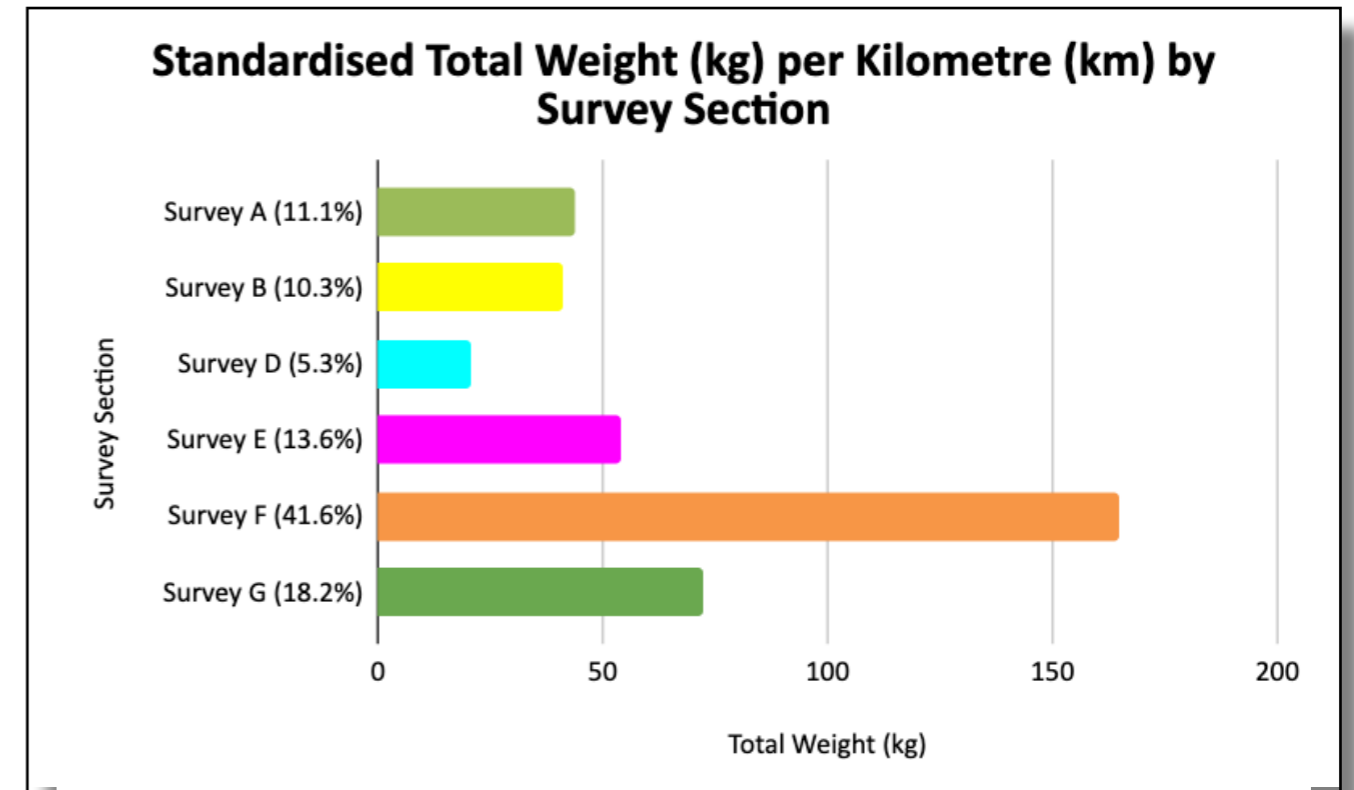
Figure 6. Standardised weight (kg) per kilometre (km) of each survey section travelled.

survey section. Figure 6 is therefore more representative with weight standardised to reflect weight per survey area based on the number of items found per kilometre (km). Percentage (%) of debris across each transect area has also been standardised to reflect the total percentage per kilometre travelled (Figure 7). From these updated results, the total weight has shifted to A, B and D being respectively 4th, 5th and 6th highest weight when standardised, whilst the total percentage per transect area has changed to pushed A to 2nd, G to 3rd and B to 4th place.

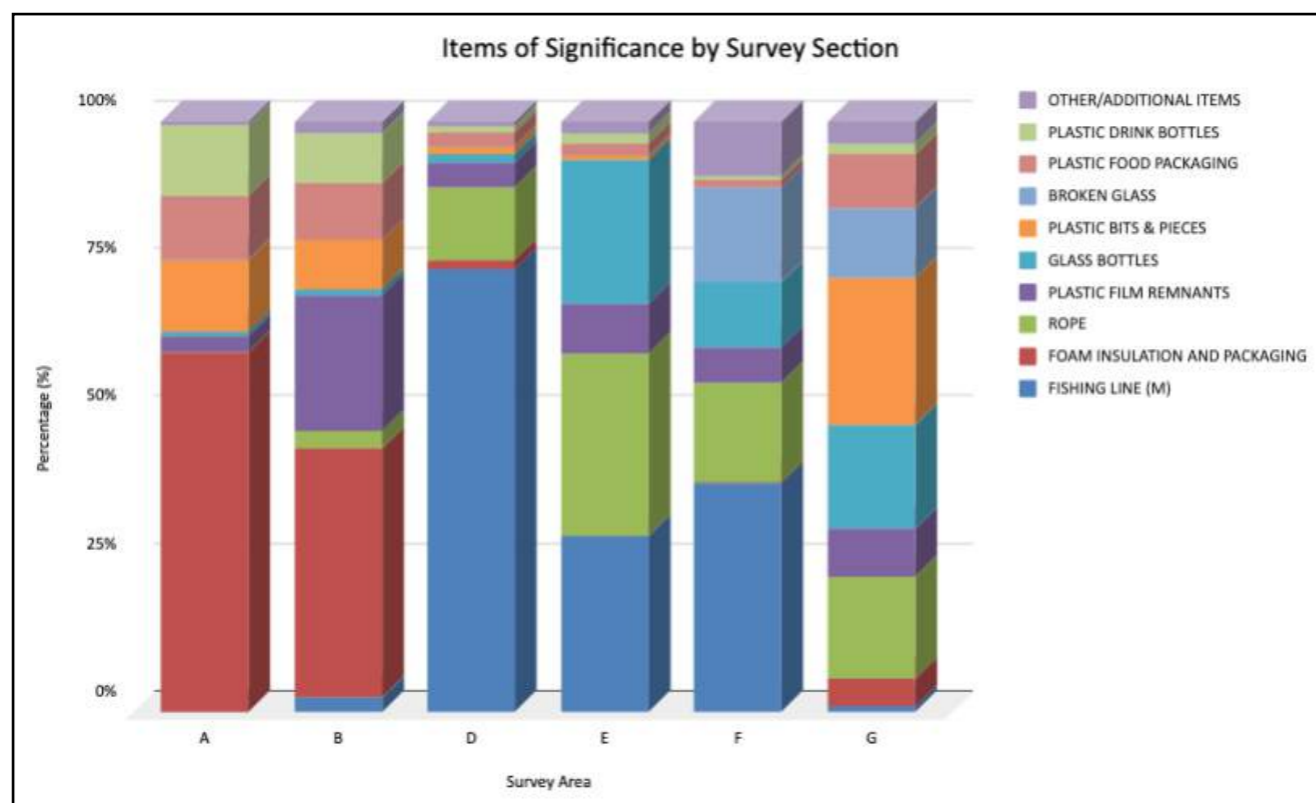
Figure 8. 10 items of significance by survey section.

In examining items of significance (Figure 8 & 9), our team assessed items that had the highest abundance and were deemed to be the biggest threat to marine ecosystems. Fishing line was the most abundant item found throughout the survey. Commercial and recreational fishing gear and fishing-related rope were also present within our top 10 items found, as well as a range of plastic and polystyrene items (with insulation and packaging (foam) being in highest abundance for polystyrene, and plastic film remnants being in highest abundance for polystyrene, and plastic film remnants the second highest plastic item (after fishing line).

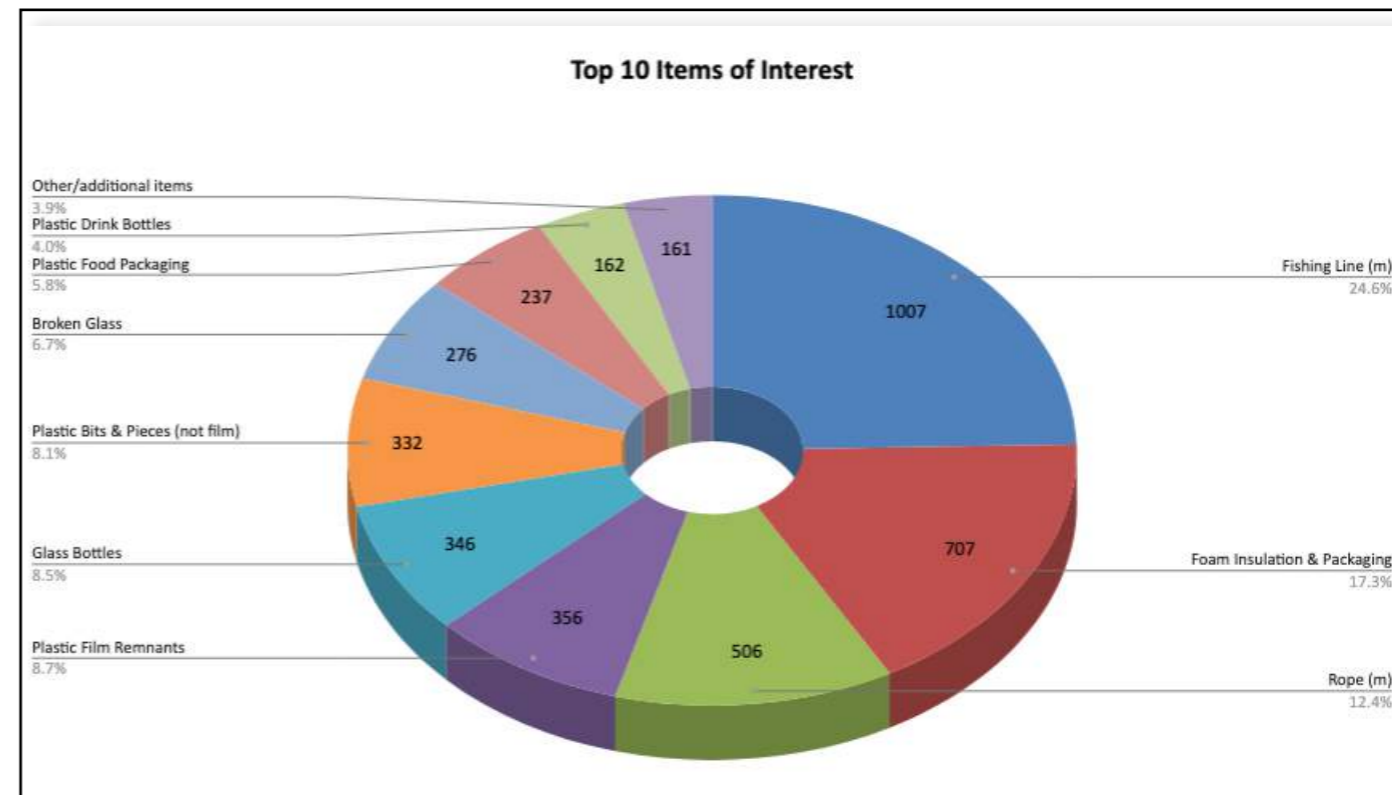
Figure 9. Top 10 items of interest across our 12 surveys.

Two items which showed up within our top 5 highest accumulation items that weren't made from plastic or polystyrene were rope and glass bottles. These items were interesting to note, as usually the top 10 items across our River Warriors project locations have all fallen within either the plastic or polystyrene categories. This will be explored further under the 'Further Insights' section on page 16, where we will draw conclusions from the data in order to understand debris trends, potential causes and mitigation measures across the waterway.

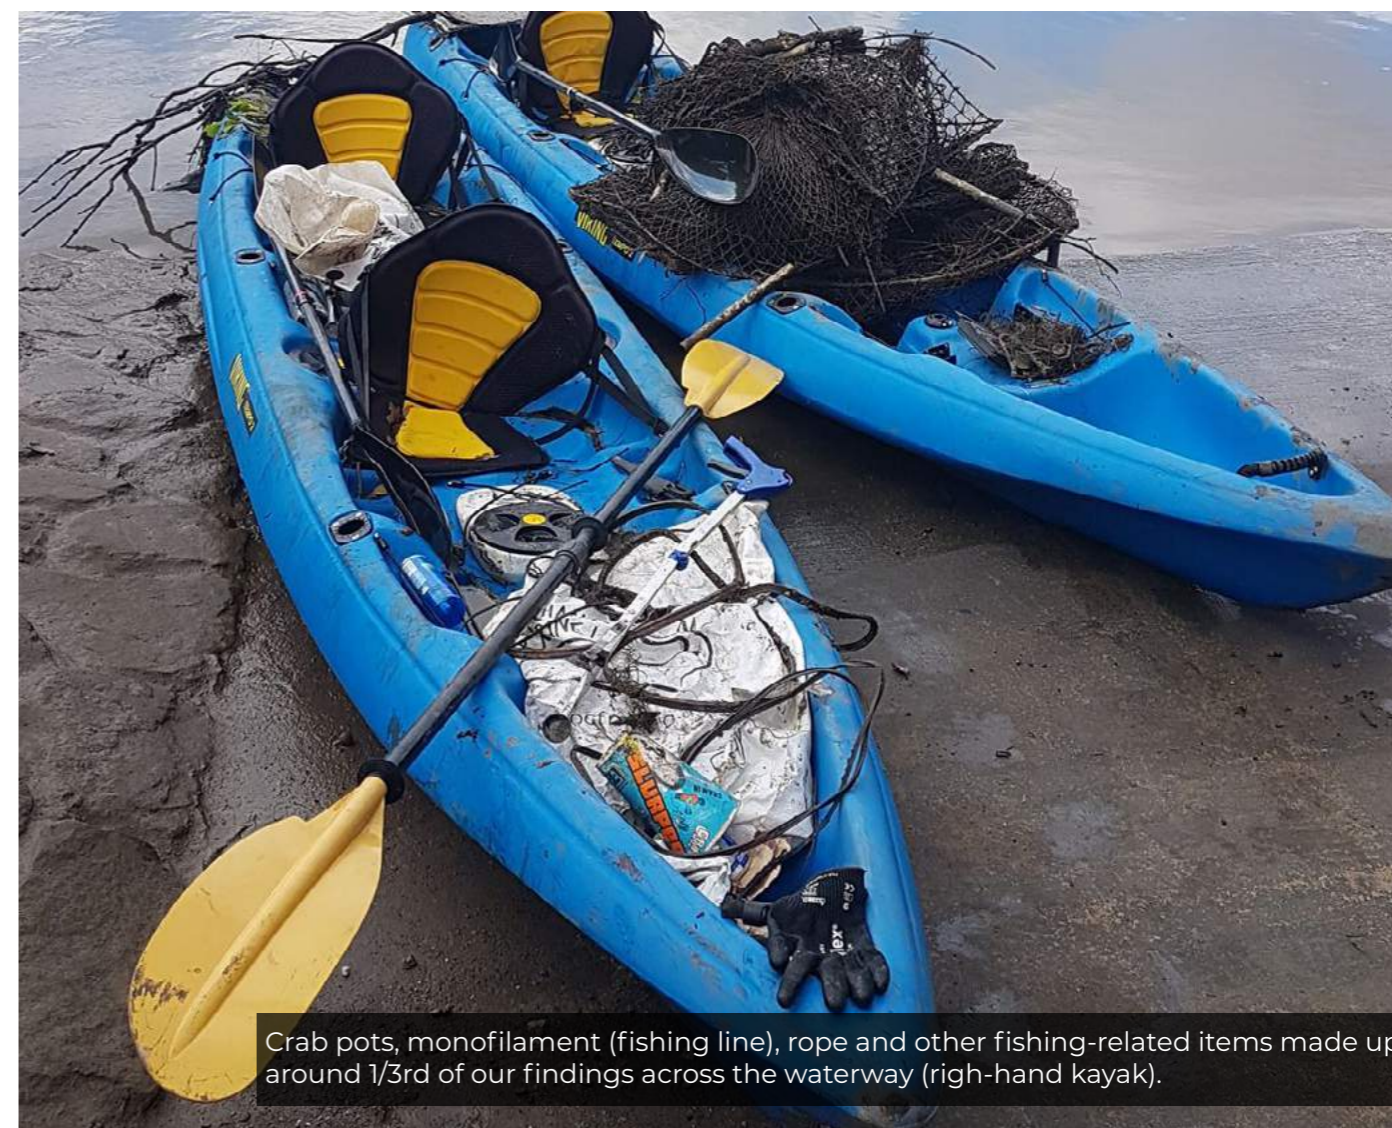
Crab pots, monofilament (fishing line), rope and other fishing-related items made up around 1/3rd of our findings across the waterway (right-hand kayak).

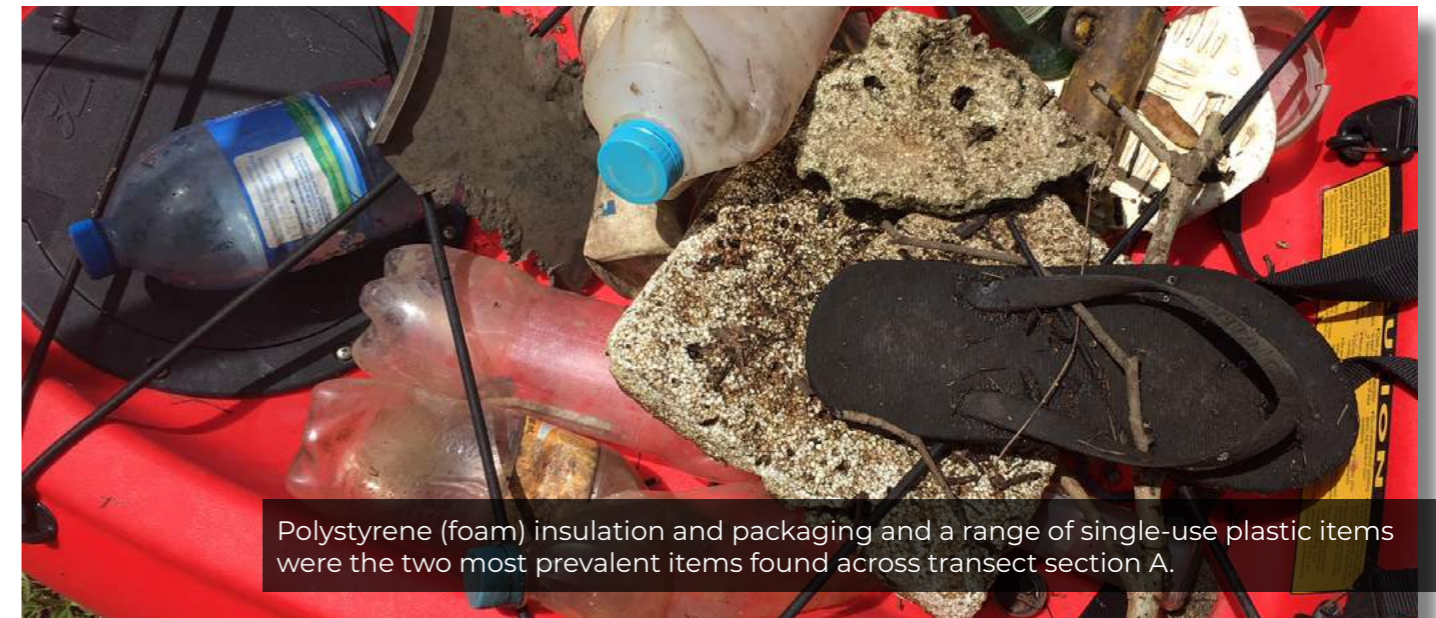
people gathering under the overpasses and who leave their litter behind. We infer that a large number of items entering this section of the waterway are due to these overpasses, with further research needed to trap litter in these areas (recommended later in this report).

Given the findings of this report, as well as our own research into this issue, we estimate that the other source of polystyrene insulation and packaging (after overpasses) is no doubt coming from local building sites, retailers and manufactures in close proximity to the area, where leakage of this material is occurring.

Polystyrene (foam) insulation and packaging and a range of single-use plastic items were the two most prevalent items found across transect section A.

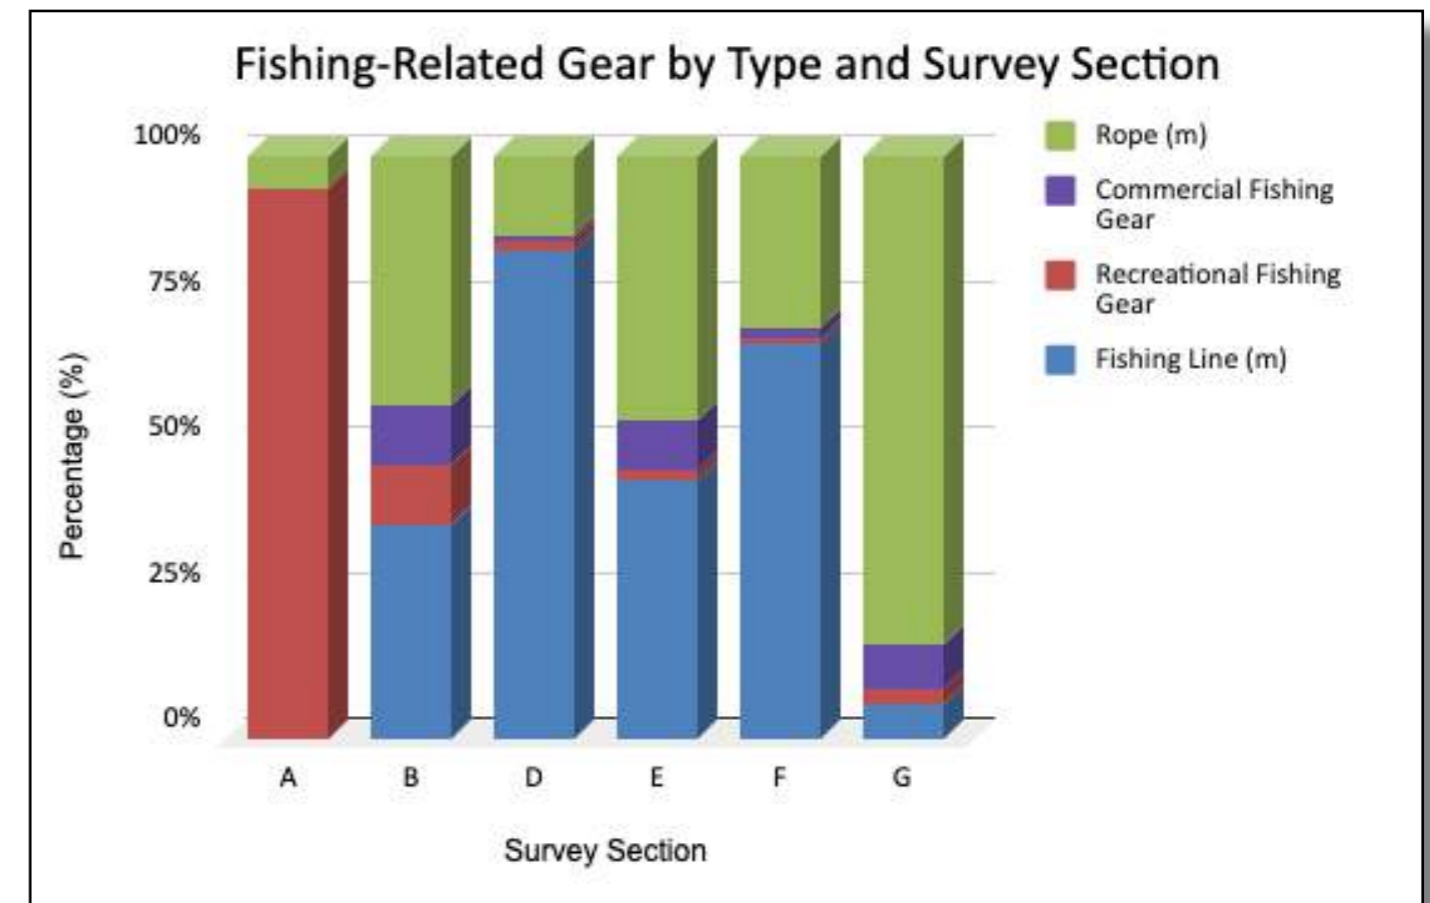
Figure 10. Fishing-related gear by type and survey section.

Due to the abundance of fishing line (monofilament) and rope as the two most found items across our River Warriors Tingalpa Creek project, we broke down our findings into a number of graphs to give greater insight into trends when it comes to fishing gear (in terms of survey site and abundance). **Figure 10** shows Fishing Related Gear by Type and Survey section, whilst **Figure 11** reflects Fishing Line Abundance by Survey Section. **Figure 12**, **Figure 13** and **Figure 14** show Rope Abundance by Survey Section and Recreational and Commercial Fishing Gear Abundance by Survey Section respectively .

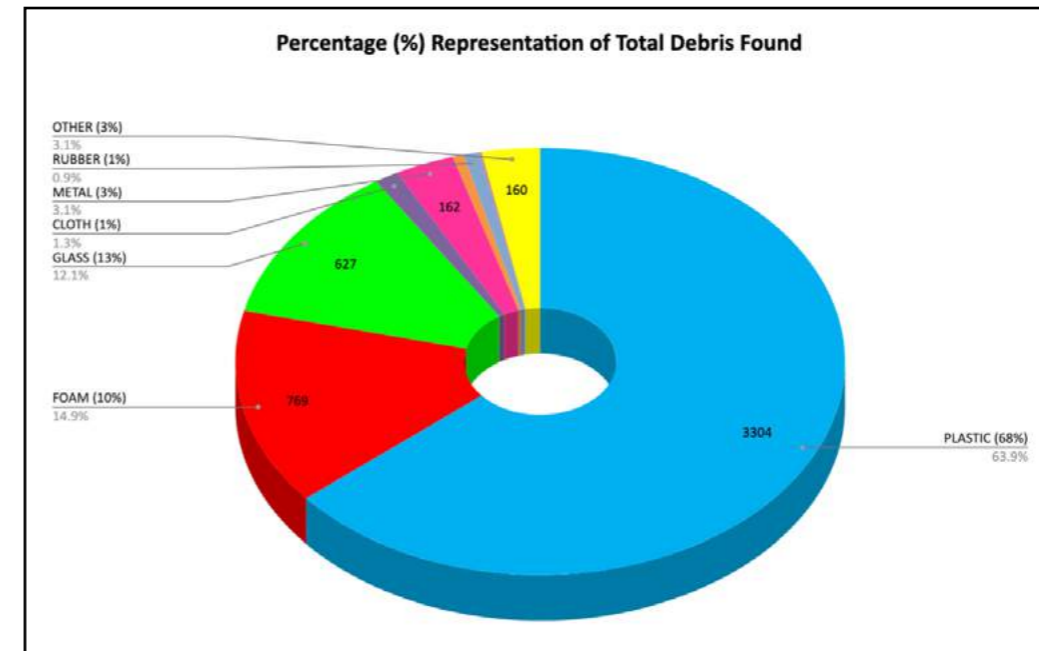
Figure 1. Total debris found - represented as a percentage.

In addition to the Snapshot on page 1, our data reflects two categories - plastic and polystyrene (foam) make up 78.2% of our findings (63.9% plastic and 14.9% polystyrene). From these two categories, the most found individual items were fishing line, plastic film remnants, plastic

bits & pieces, plastic food packaging and, plastic drink bottles, making up 63.4% of the total plastics found. Polystyrene was largely made up of insulation and packaging at 92% of its total (Figure 1).
