BRUNSWICK RIVER REPORT

2022

INTRODUCTION

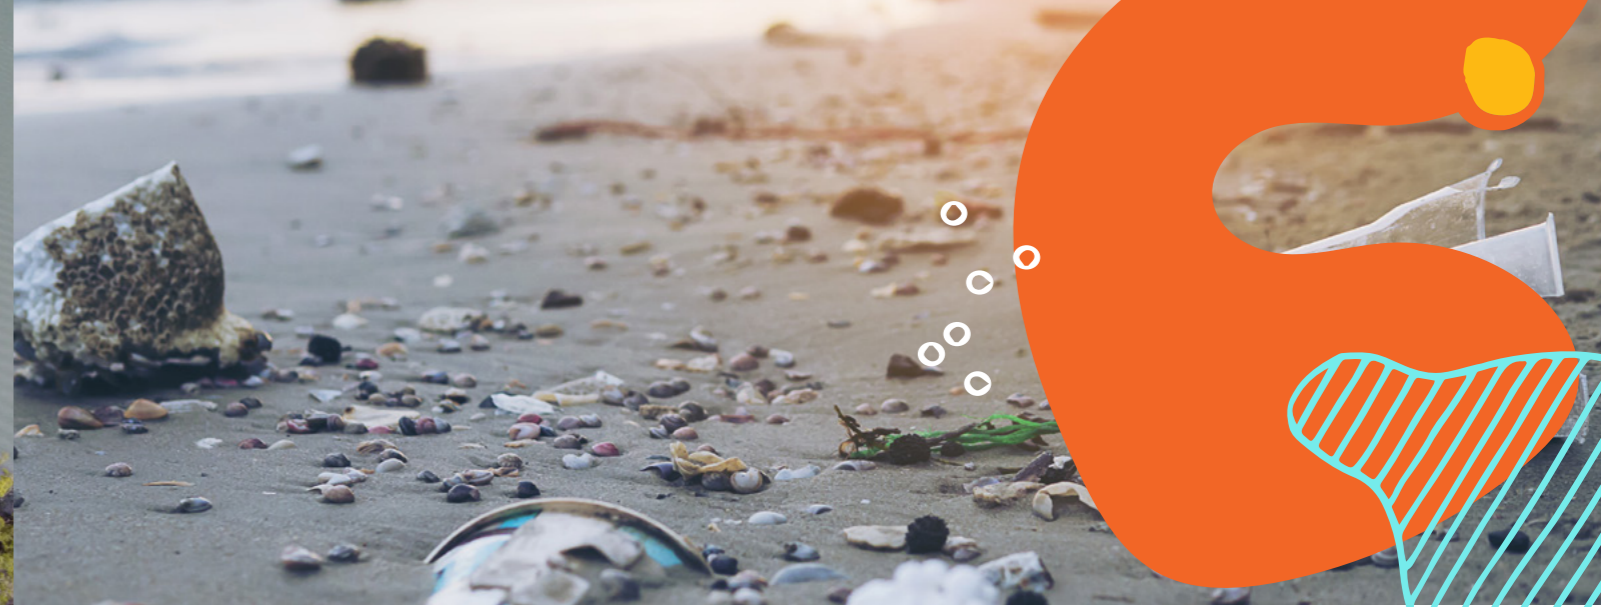
CATEGORY 1	CATEGORY 2	CATEGORY 3
Moderate amount of marine debris present	Large amount of marine debris present	Very large amount of marine debris present

Moderate amount of debris scattered within close proximity - the amount present would fill less than ¼ of a standard 240L wheelie bin.	Large amount of debris and hard waste within close proximity - the amount present would fill between ½ and 1 standard wheelie bin.	Very large amount of debris and hard waste is widespread across a sizeable area. The amount present would fill more than 1 standard wheelie bin.

Figure 5. Reference cards for marine debris hotspot categories identified from the mouth of the Brunswick River upstream to the town of Mullumbimby.

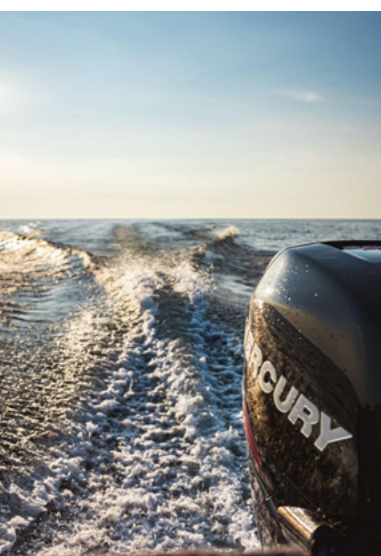
Figure 8. As motorised watercraft move through the river their hull displaces water, pushing a wave, or wake behind them. This wake breaks against the banks, with the force breaking down sediments - contributing to undercutting and instability.

Motorised boating represents an important recreational use on the waterway however, the wake formed by the passage of even small boats operating above a certain speed creates waves that will travel hundreds of metres until their energy is dissipated. These waves break against the banks of the shore, removing sediments and gradually breaking down the toe of the bank (Cox & McFarlane, 2019). Studies in New Zealand have shown that motorised vessels can generate waves up to eighty times larger, and with one hundred times more energy than background/natural wind-generated waves (Mcconchie et al. 2003). Particularly in narrow, shallow waterways (which describes much of the Brunswick River), boat wake has also been directly linked to erosion and increased turbidity (Bilkovic et al. 2019). Coupled with other erosive action, it can lead to slumping, bank failure and collapse - even in stretches with healthy riparian vegetation. In many stretches of the Brunswick, this is evidenced by rows of fallen trees, lying perpendicular to the banks.

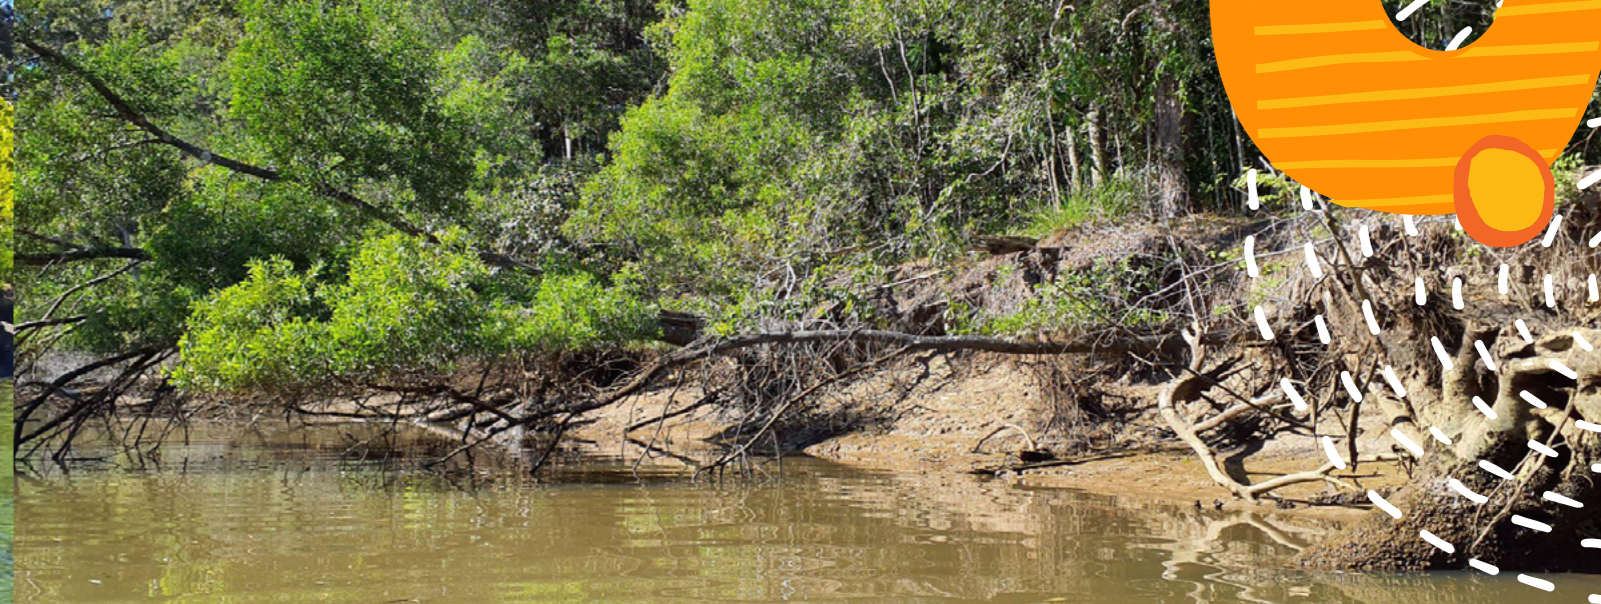
Figure 9. Bank collapse and fallen trees along a stretch of the Brunswick River.

the river, and clear signage and an enforcement presence to ensure compliance. A range of bank stabilisation techniques (specifically designed to mitigate the impact of boat wash and enhance the resilience of the bank toe to this form of erosion) can also be applied. These major interventions are best implemented in worst-affected stretches, in synergy with other restoration practices, as discussed later in this report.

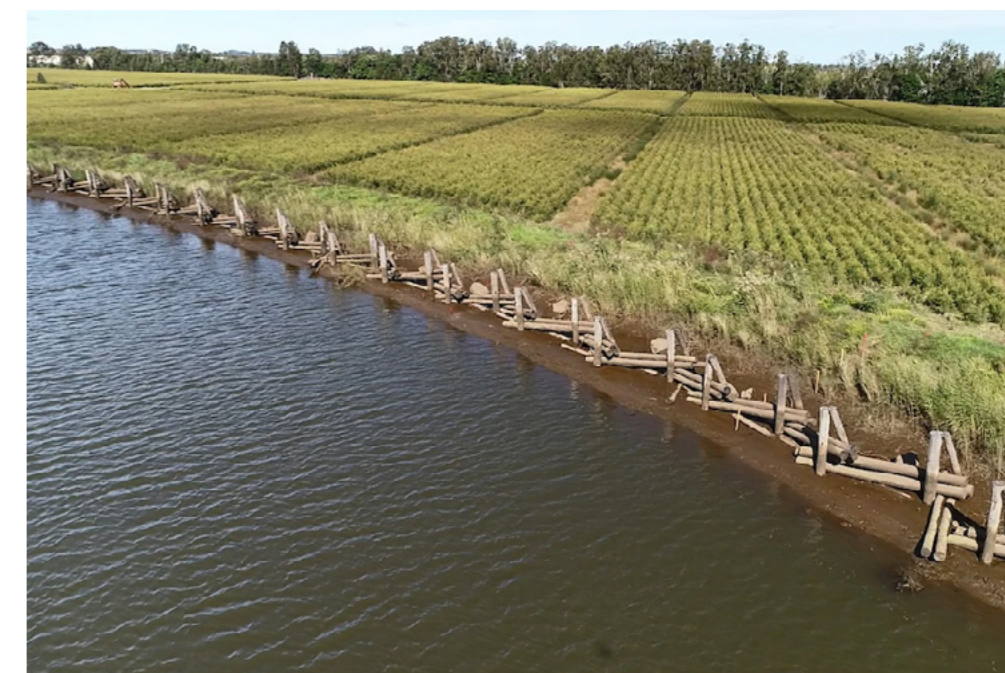
Figure 10. Log fillets, pictured here - are one of the riverbank restoration techniques specifically designed to protect the bank toe from boat wash, providing shelter for native vegetation (such as mangroves) to recover.

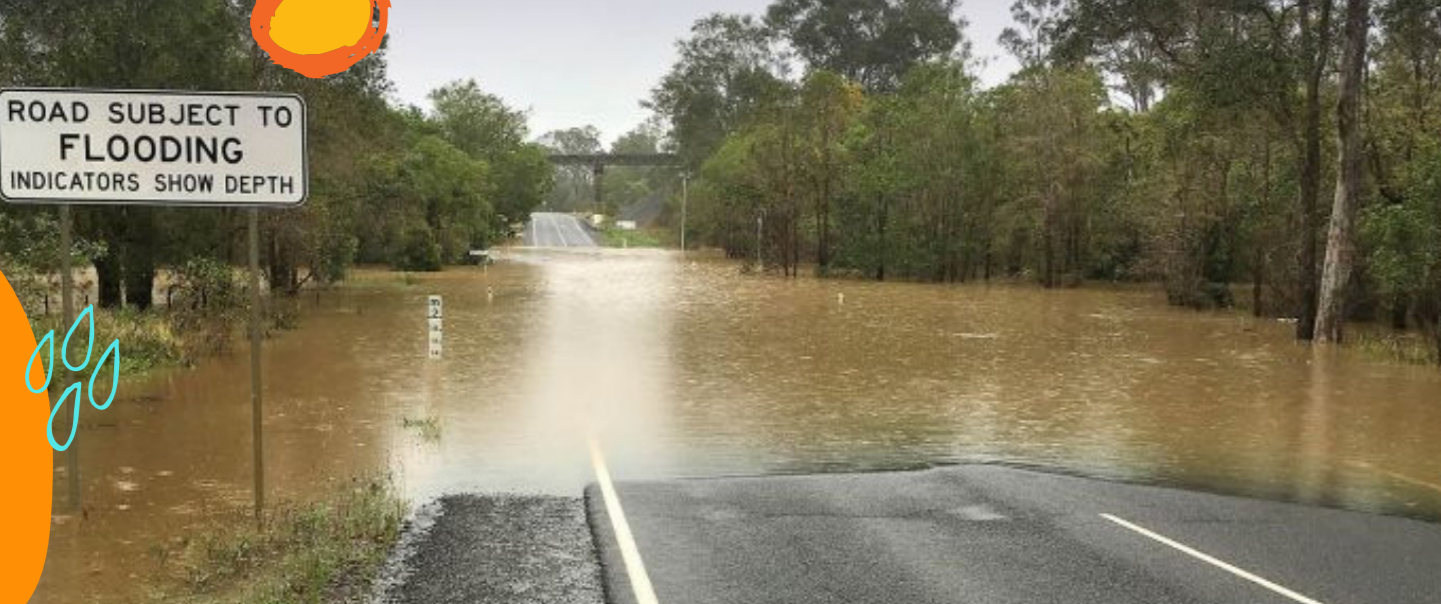
Figure 11. Flooding can cause rivers to overflow, damaging vegetation, increasing flow speed and further eroding banks where there is limited or no vegetation present to protect them.

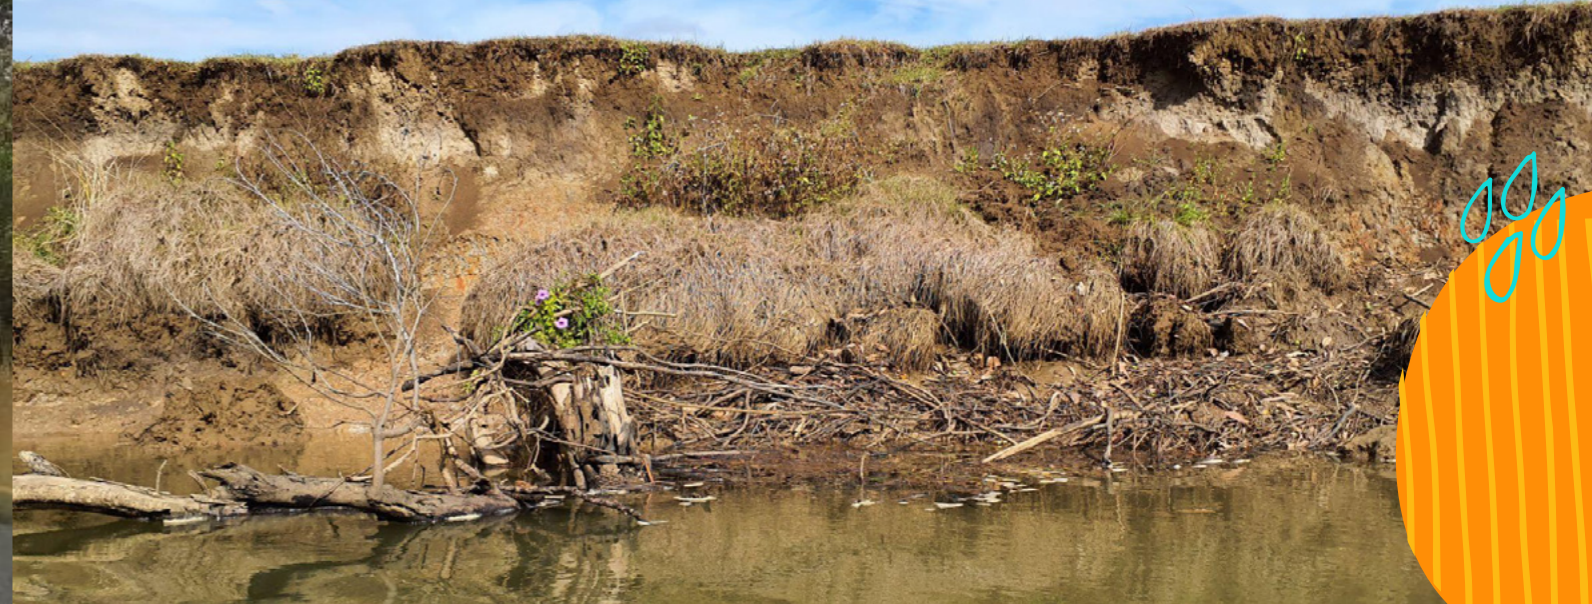
Figure 12. When riparian habitat is entirely cleared - it can have a disastrous impact on riverbank stability and erosion, especially when cattle have unrestricted access to the water.

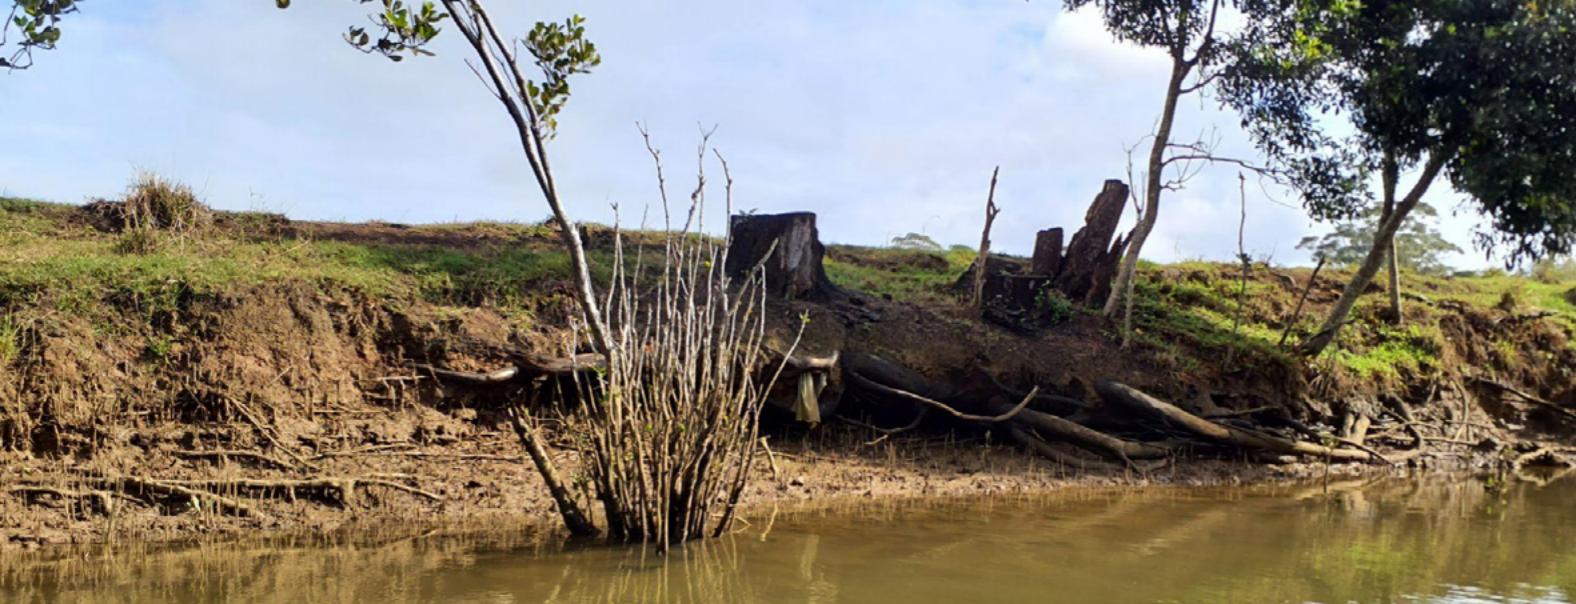
Figure 13. Here, cattle access has destroyed what little vegetation remained after clearing, with an almost entirely denuded mangrove tree and its trampled root system exposed.

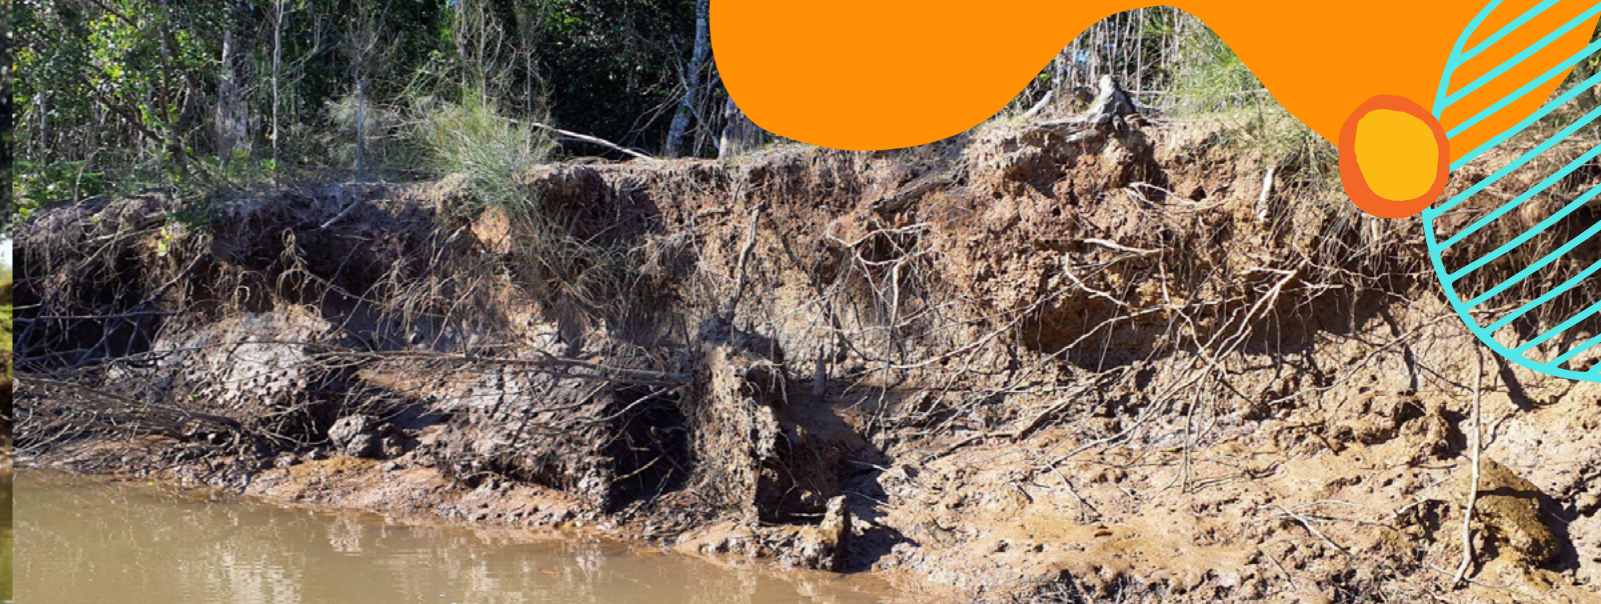
Figure 15. Heavily eroded banks showing murky, turbid, sediment-laden water below.

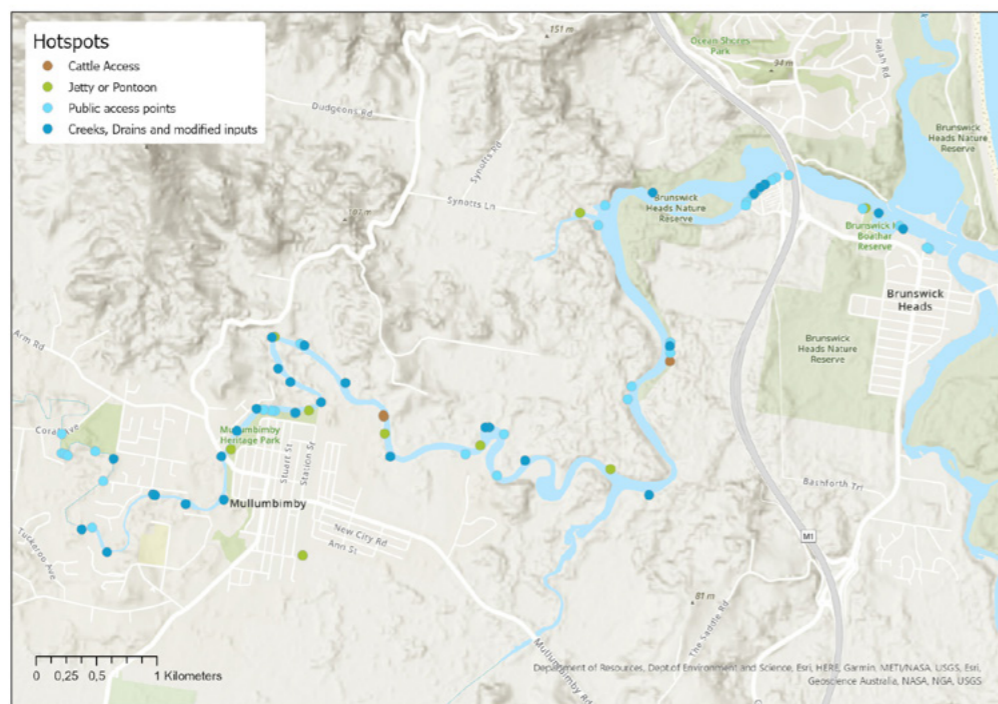
Figure 14. Human and cattle access points, jetties and pontoons, and various inlets along the lower to middle reaches of the Brunswick River.

By mapping jetties, and recreational and cattle access points on the waterway, we were able to identify high impact activities. Examining these in conjunction with stability maps further confirmed that the more tightly meandering stretches just south of Mullumbimby suffered from greater erosion and access issues than lower reaches. This information will be critical when considering potential restoration sites. It is worth noting that properly constructed jetties and pontoons can provide much better river access alternatives, restricting the footprint and damage to the riverbank and surrounding vegetation, however poorly managed they can become a hazard and also contribute plastic and polystyrene marine debris into the waterway, which can wash out into the Cape Byron Marine Park.

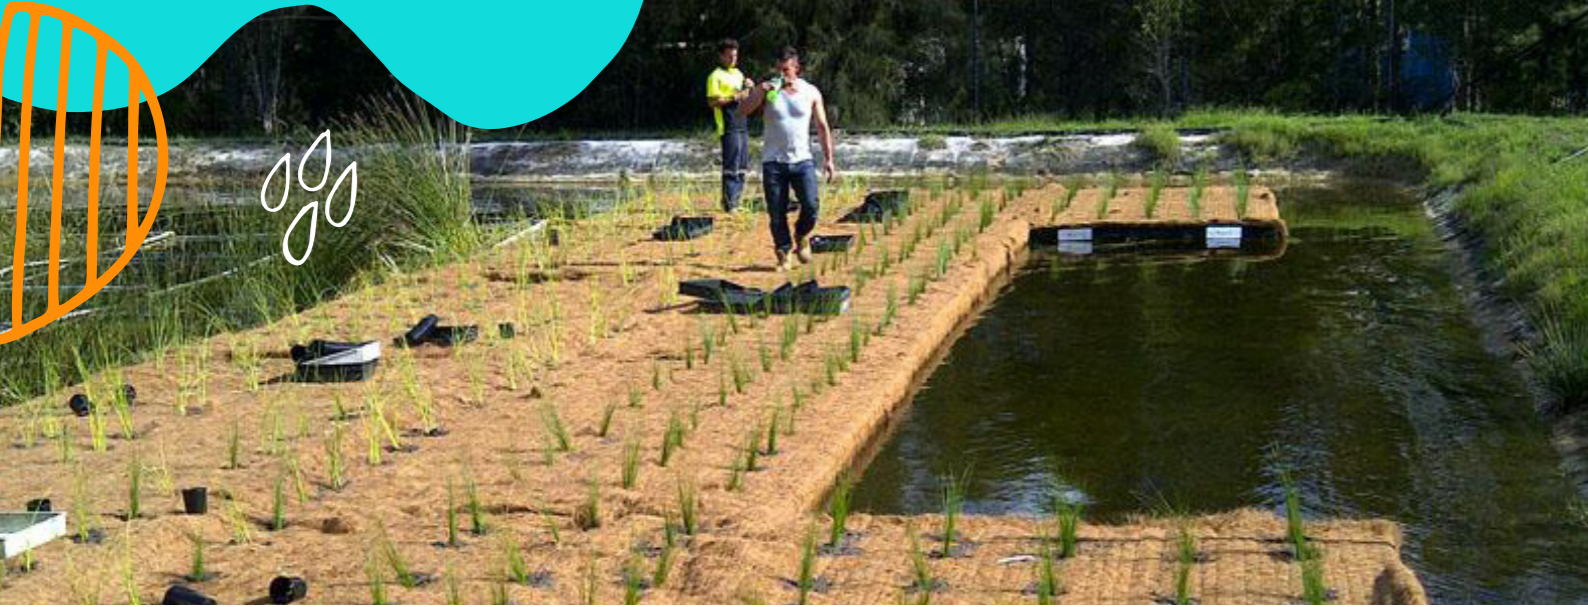
Figure 16. Floating wetlands are just one possible hybrid engineered solution to help dramatically reduce in-stream pollutants and nutrients.

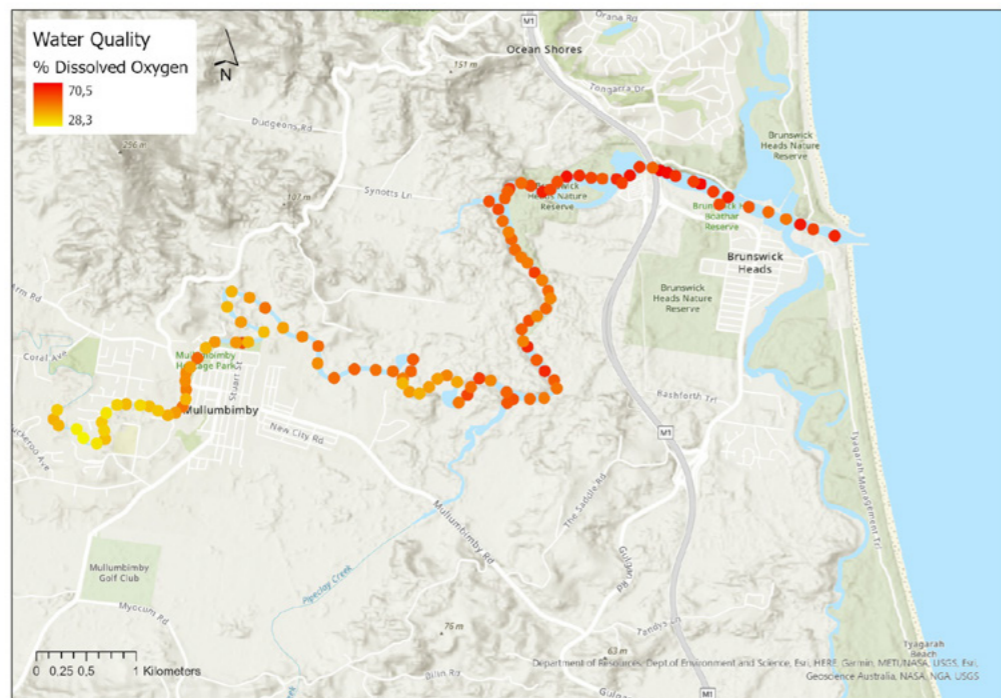
We observed decreased oxygen levels from the oxygen-rich water flushed in from the ocean as we sampled upstream into Mullumbimby. The decrease is particularly noteworthy at the bend just northeast of Manns Road - directly downstream of the decommissioned Sewage Treatment Plant (STP). A suggested hypothesis is that this area is affected by increased nutrient run-off from the water treatment plant, leading to increased microbial and algal activity, reducing dissolved oxygen along this section. However, this warrants further investigation, specifically testing for nitrates and phosphates in the water column. Decreased dissolved oxygen in the more developed stretches of the river, near Mullumbimby, also warrant additional testing for nutrient levels and source. This further testing could determine whether engineering solutions (such as constructed wetlands) could serve as mechanisms to increase aeration, flow management and source reduction. Discussions with technical partners around exciting new techniques and developments such as artificial, floating wetlands have already begun in anticipation of our future restoration and mitigation projects.

Figure 17. A snapshot of Dissolved Oxygen (DO) shows the shift from more oxygenated water from the ocean on a given tide, slowly decreasing upstream.

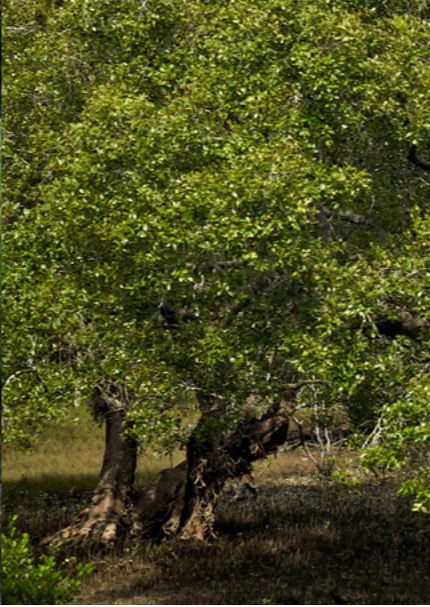
Figure 18. Initial surveys showing exotic invasive vegetation along the estuarine reaches of the Brunswick River.

Whilst many sections of the river require invasive species control, we have identified three areas of particular concern. Across large tracts of riparian land in the lower estuarine reaches (particularly upstream of the M1 overpass) ground asparagus (*Asparagus aethiopicus*) has completely smothered native ground vegetation, outcompeting valuable saltmarsh habitat. Frequent presence of Coastal Morning Glory (*Ipomoea cairica*) and Lantana (*Lantana camara*) were noted in the middle reaches, and large numbers of Umbrella Trees (*Schefflera actinophylla*) were recorded on the banks to the south of Mullumbimby.

Camphor Laurel (*Cinnamomum camphora*) is common across all but the lower reaches of the river, making it one of the most entrenched invasive species in the catchment. Camphor can invade and grow vigorously to form dense thickets, excluding native vegetation from an area. It fruits heavily, and is rapidly spread by several bird species. Its dense, shallow roots and thick canopy cover tend to exclude ground cover through overshading and can further weaken riverbanks (Firth et al. 2014). Despite this, in some degraded stretches, very old camphor tree root structures act as the last form of bank toe protection, making their removal challenging. Because of this, it is important to incorporate rehabilitation strategies that take this into consideration, such as successional planting or bank stabilisation works.

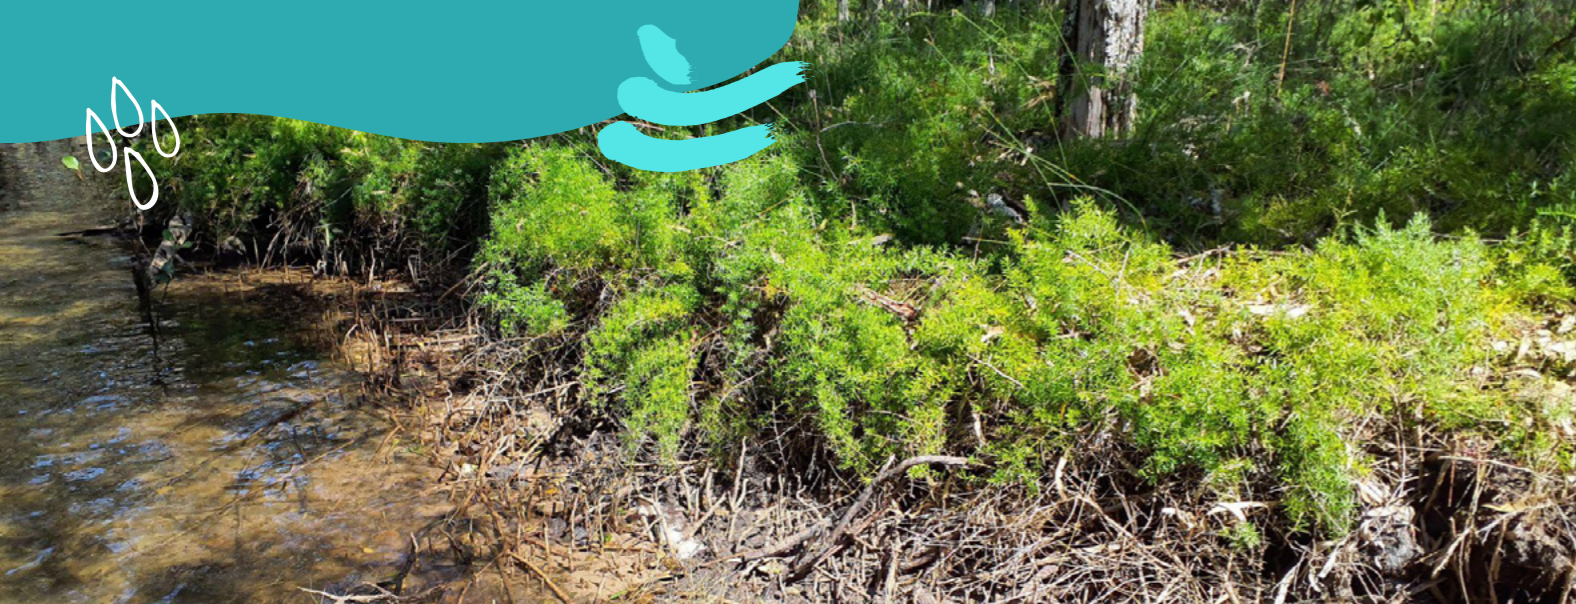
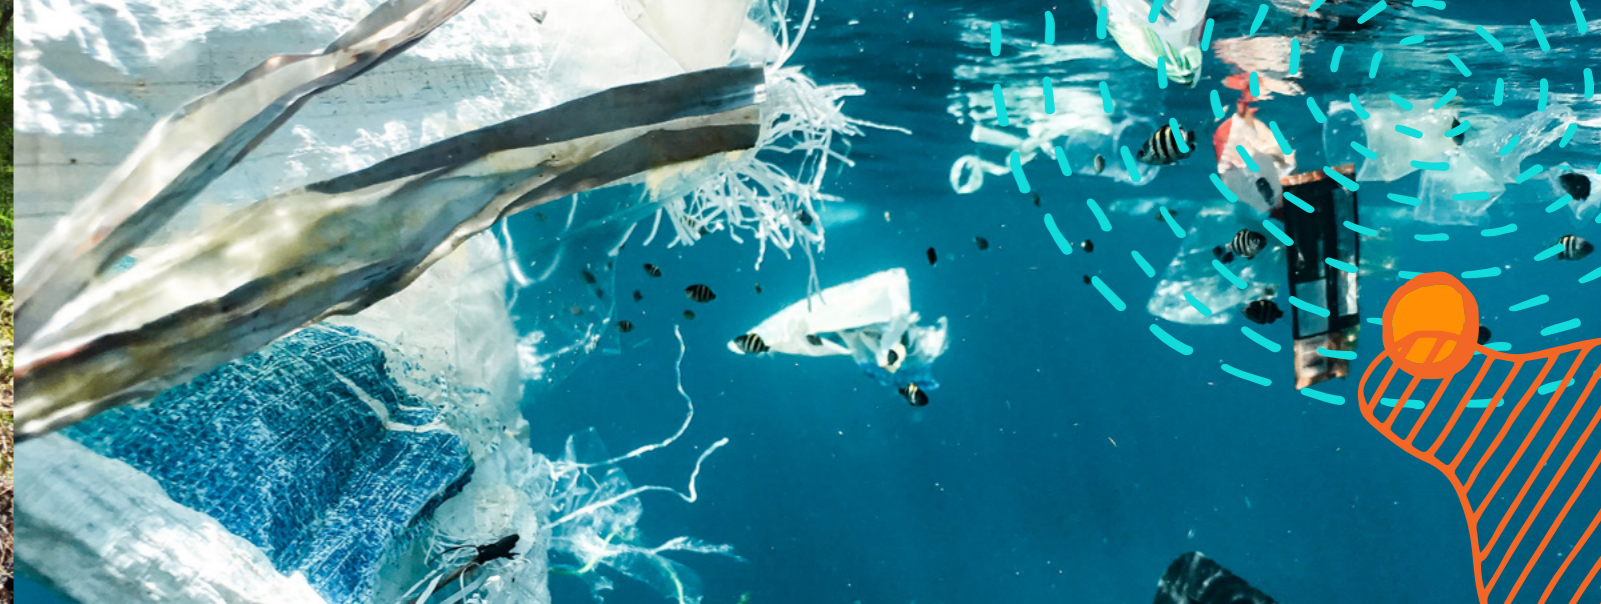
Figure 19. During our surveys we identified large areas where Ground Asparagus (*Asparagus aethiopicus*) has heavily invaded banks, upstream from the M1 overpass.

It is our recommendation that invasive species control programs are assessed, strengthened and well-monitored to mitigate any unintended consequences of control measures. Regeneration of native species should complement these invasive mitigation measures and the existing alliance of local groups strengthened to increase community participation, while decreasing reliance on chemical inputs, which can further harm natural processes.

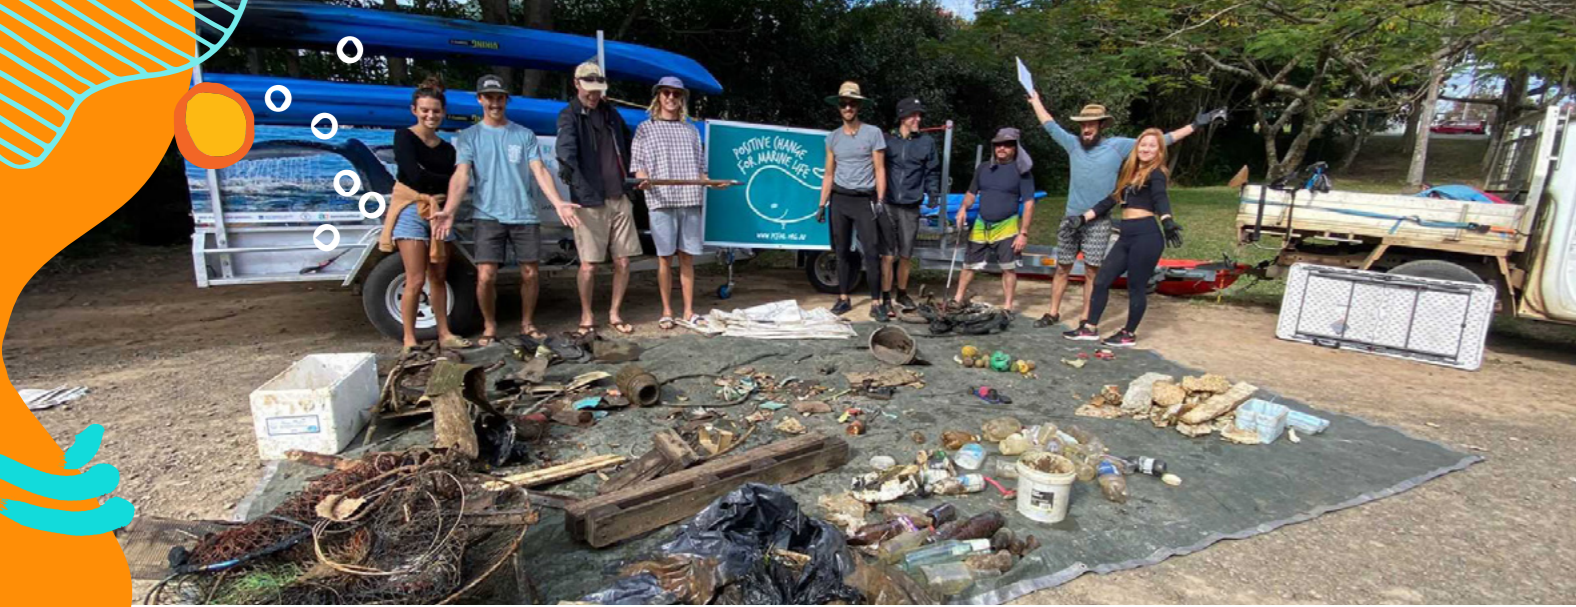
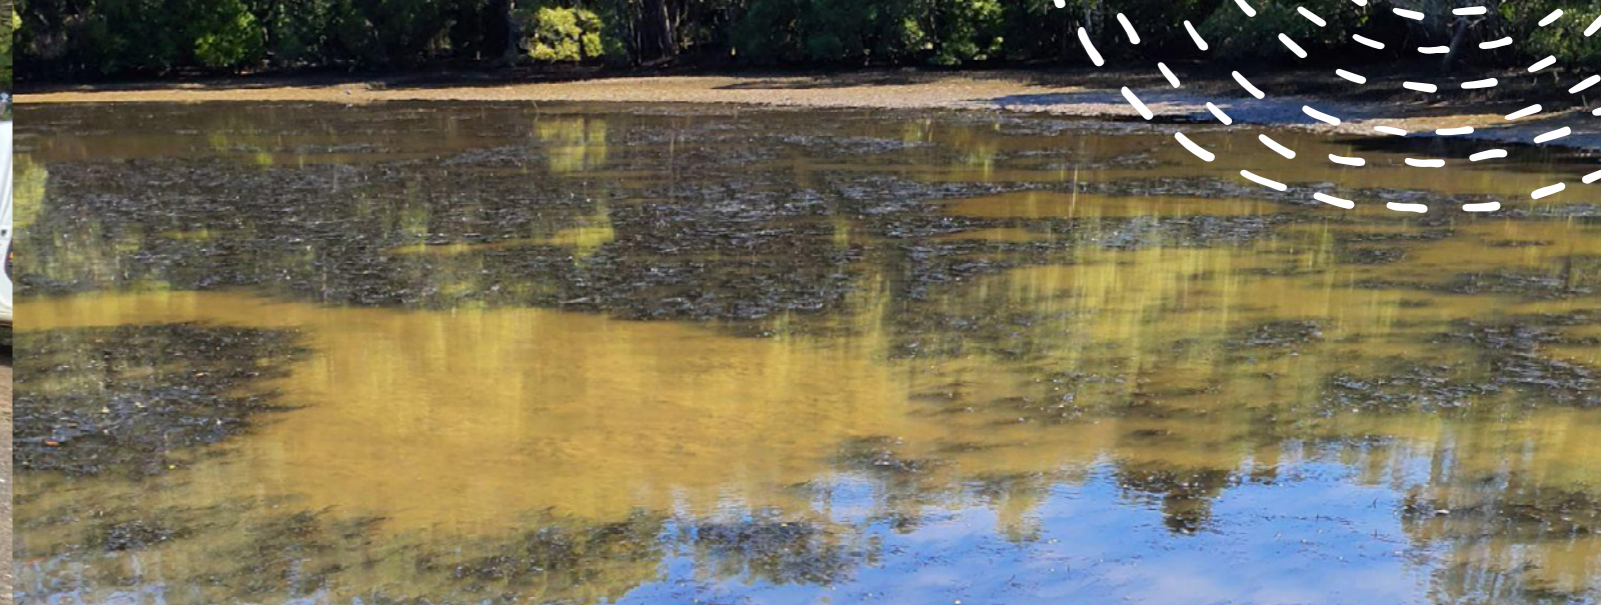
Figure 20. Map showing identified Marine Debris Hotspots on the Brunswick River.

The results of our mapping exercise suggest that the banks closest to the mouth of the Brunswick River show fewer, and less severe marine debris hotspots than the middle reaches leading up into Mullumbimby (figure 20). This is supported by findings from past projects, when significantly more debris was collected from the middle reaches (66 pieces of debris collected per volunteer hour) vs lower reaches (19 pieces per volunteer hour).

The greater abundance of marine debris in the middle reaches is likely due to two factors - 1) the winding nature of the river in this stretch, coupled with thicker patches of riparian vegetation provides greater catch-points for marine debris to accumulate when making its way downriver (close enough to the estuary mouth/tidal range for large catchment flows, but not tidal enough for the greater pull closer to the mouth) and, 2) development pressure on the riverbanks increases further upstream towards Mullumbimby, resulting in a greater abundance of debris.

Some of the hotspots identified include old and derelict dumpsites that appear to have gradually been exposed over time. We know from our previous marine debris-focused projects that the main waste types found across similar transect areas near Mullumbimby included litter and debris from urban development, informal dumpsites, localised littering and overflow from properties, single-use food packaging, and buoyant foamed plastic transported via tides and river flow. Something to take into consideration is that the lower reaches of the river are armoured with rock fill. Although this does trap some marine debris, the steeper banks and more uniform structure is less likely to capture litter than mangroves or vegetated banks.

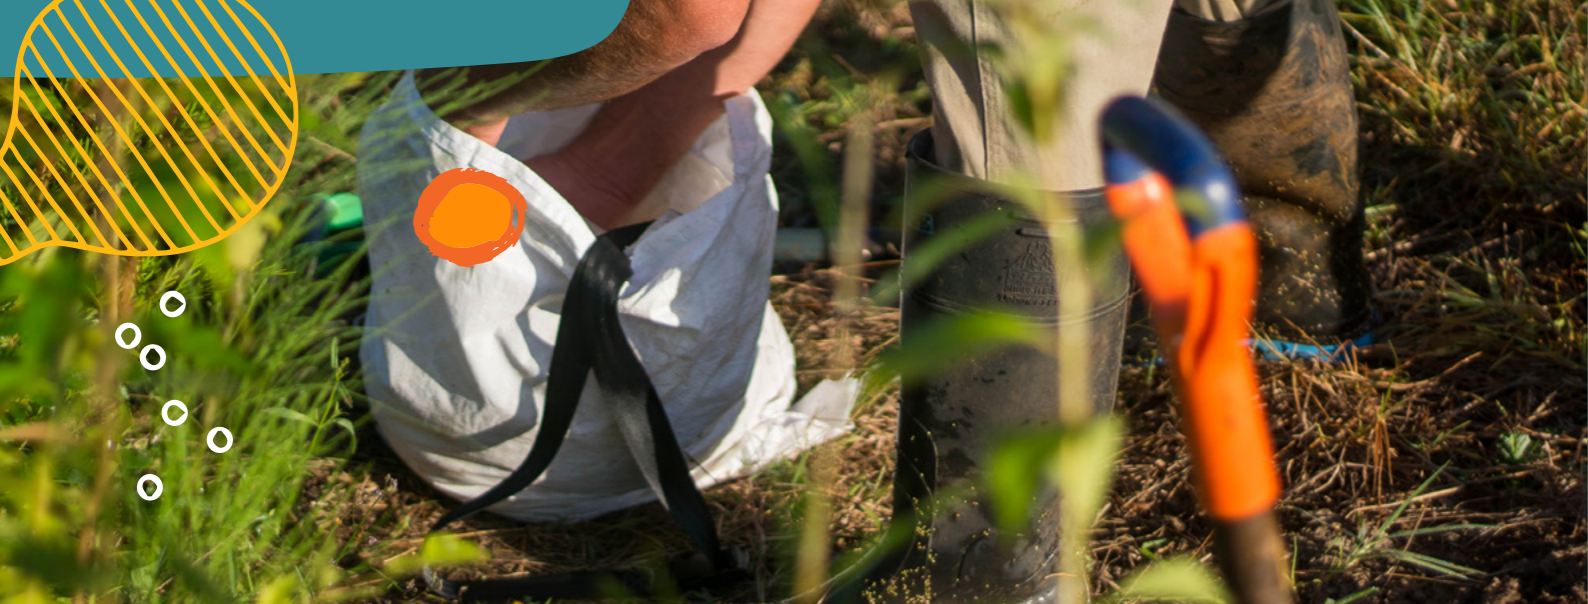
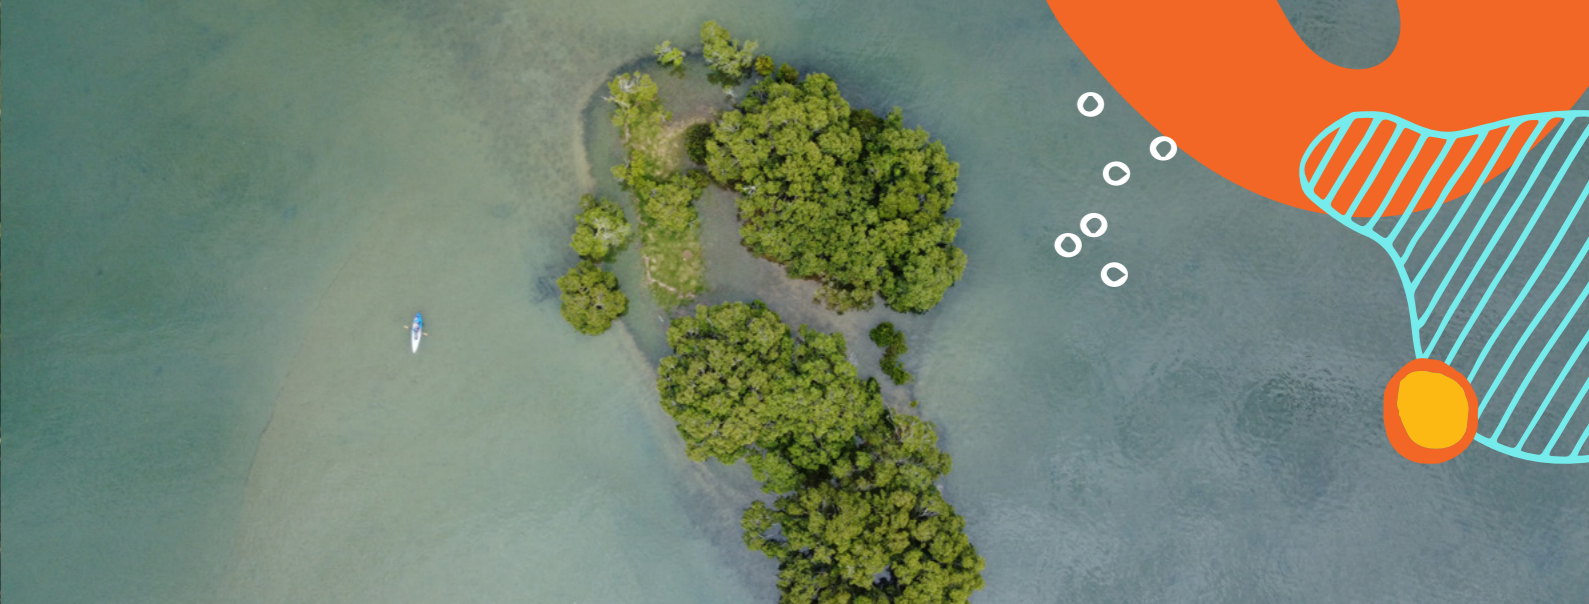
Figure 23. Landcare, Dunecare and Byron Shire Council's existing habitat restoration sites on and around the Brunswick River.

Byron Shire Council (BSC), Brunswick Valley Landcare (BVL) and the NSW National Parks and Wildlife Service (NPWS), among others, have been actively involved with habitat restoration, weed control and revegetation across a range of sites adjacent to the Brunswick River (Figure 23). This includes a significant project by Byron Shire Council as part of their *Bring Back the Bruns* campaign, targeting a stretch of the most severely degraded banks of the river. Despite this, there is still a lot of work to do, with much of the land fringing the river in a very poor state. This is reflected in the NSW EPA 2021 State of the Environment Report, which rated the river moderate-poor in terms of health.
